Broadleaf watermilfoil

Managing broadleaf watermilfoil on the Somme River and its canals

Somme departmental council

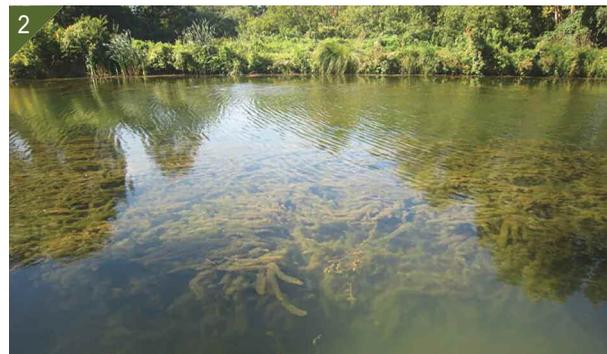
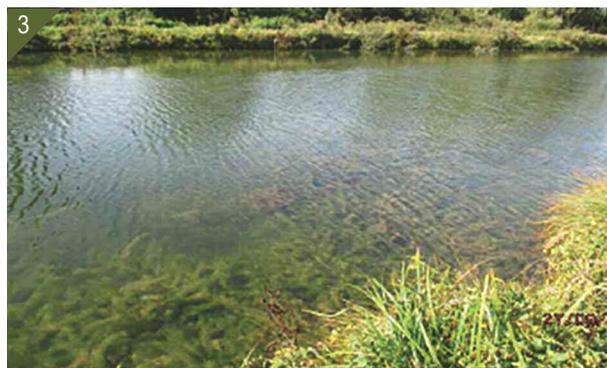
2, 3. Zones colonised by broadleaf watermilfoil.

- Broadleaf watermilfoil, due to its density and the formation of the thick mat on the water surface, is a major hindrance for fishing, water sports and boating.
- In that it blocks the growth of native submergent plants, the species represents a considerable threat for biodiversity and the ecological balance. It can reduce the reproductive success of fish by limiting access to spawning grounds.
- Finally, large quantities of broadleaf watermilfoil can alter the chemical parameters of the water by increasing the pH and reducing the quantity of dissolved oxygen.

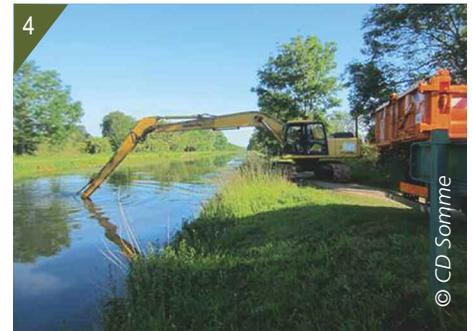
4. Harrowing from the bank.

■ Harrowing consists of scraping the river bed in order to uproot the plant, using a harrow mounted on an excavator. The work was done from the bank using a 22-ton excavator equipped with a 15-metre boom.

■ This technique has the advantage of removing the root system of the plant and avoiding the risk of trapping alevins when pulling the plants onto the bank, however the great weight of the machine may damage the banks, dikes and trails.

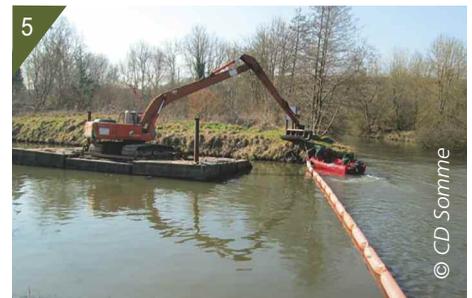
5. Harrowing from a barge.

■ The work was repeated in 2016 on the seven sites most affected by the broadleaf watermilfoil, representing a total of 14 hectares. In order to avoid damaging the dikes and the vegetation along the water courses, the excavator equipped with the harrow was installed on a barge that was positioned by a pusher-boat.

- The system for mechanical uprooting was the same as in 2016, i.e. the harrow was mounted on an excavator that worked from a barge. Particular care was taken in the channelised section to ensure that the excavator did not dig into the canal bottom and impact its watertightness. After harrowing, the plants were transported on a barge to a temporary site, before being sent to the storage sites.

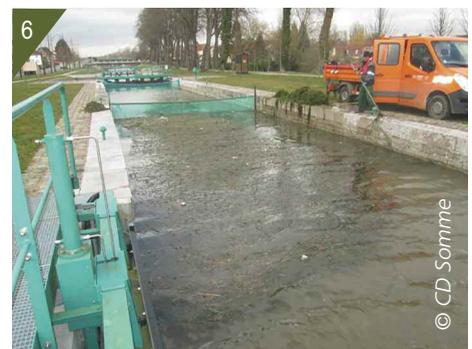
6. Nets in the canal to avoid dispersal.

■ As a precautionary measure, nets were placed downstream of the work zone to collect any watermilfoil fragments and avoid the dissemination of the plants.

- Nets were set downstream of the work site and any floating fragments were collected using dip nets during the uprooting work to avoid their dispersal.

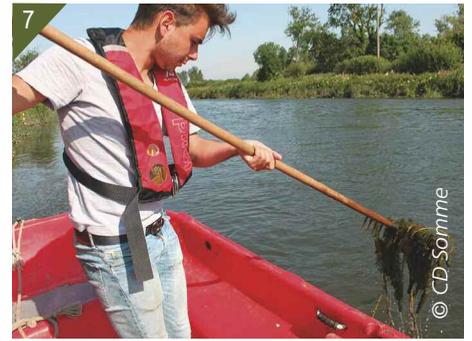
7. Drawing a sample of watermilfoil.
8. Manual uprooting of broadleaf watermilfoil.

- Out of a total of 98 samples, 13 corresponded to whorl-leaf watermilfoil and the rest to broadleaf watermilfoil. The two species were identified in the upstream section of the river, but only broadleaf watermilfoil was found in the downstream section. It was particularly prevalent in the immediate vicinity (upstream and downstream) of locks, where it formed large beds.
