# Parrot-feather watermilfoil

## Managing parrot-feather watermilfoil in the Riondaz pond in Viriat (Ain department)

### The Reyssouze river-basin board (SBVR)

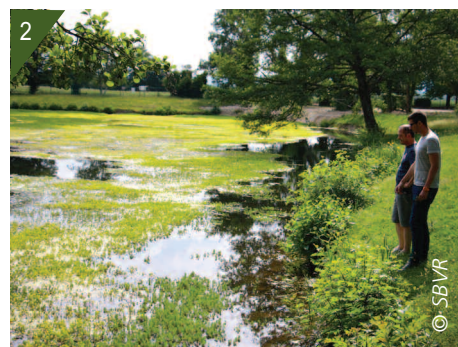
2. The pond colonised by parrot-feather watermilfoil.

- Over the two-year period, the PFW developed considerably in the pond. In 2017, it had covered the entire surface area of the pond and replaced the previous beds of aquatic plants.

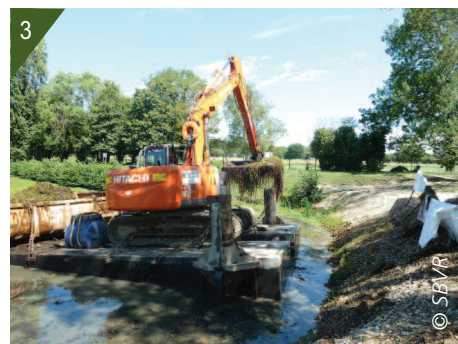
3. Mechanical uprooting by the excavator on a barge.

- SBVR decided to launch a project to manage the PFW in order to avoid any risk of species dispersal to other sites in the river basin and to restore the recreational activities desired by the pond owner.
- The work consisted of uprooting the PFW using an excavator loaded onto a barge that enabled it to access the entire surface area of the pond. The excavator was equipped with a special bucket with "claws" designed to gather a maximum amount of plants while leaving the fine and coarse sediment.

■ The work took place over seven days in August, including five days of uprooting.

■ The mechanical uprooting in 2017 covered almost the entire pond and approximately 40 metric tons of drained plants were later transported from the site. A small island was removed manually because the low water level during the summer hindered the access of the barge.

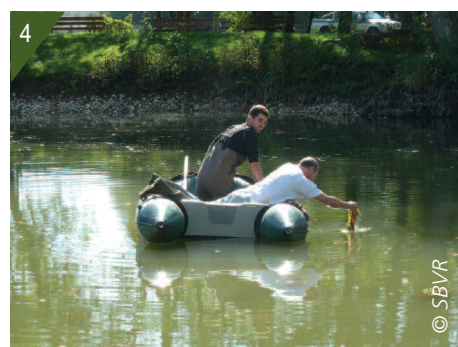
4. Follow-up manual uprooting from a boat.

■ In September and October, two sessions of manual uprooting from a boat were organised to reduce the quantity of new growth.

■ To avoid regrowth of the plants, four sessions of manual uprooting by volunteers were organised in 2018:

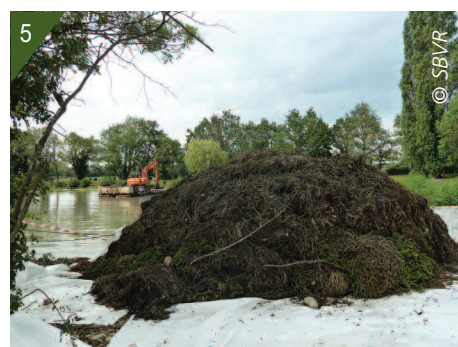
5. Green waste produced by the mechanical uprooting in 2017.

■ The green waste was stored on a site where there was no danger of flooding. The waste was placed on a geotextile fabric to avoid contact with the soil. The PFW drained and dried *in situ* over a period of several weeks before being transported to a special centre for burial.

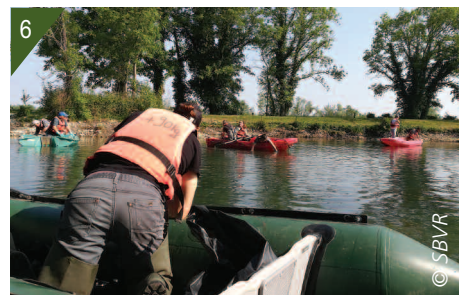
6. The manual-uprooting team on 5 May 2018.
7. The young volunteers from Concordia at work in August 2018.
8. The project displayed on the front page of the local, weekly paper *Le Progrès*.

- two days in conjunction with FRAPNA (environmental-protection non-profit) on 5 May and 29 September;
- two five-day sessions in conjunction with Concordia (work programmes for young volunteers) from 16 to 20 July and from 13 to 17 August.
