## Invasive alien species in aquatic environments

### Practical information and management insights

## Volume 3

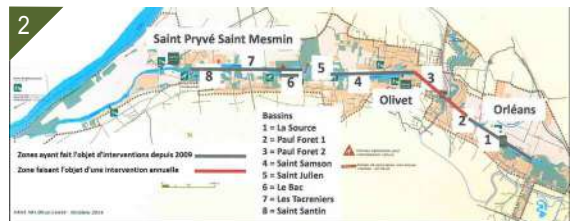
1. Homes along the first reach of the Loiret River.
2. Map of the intervention areas along the Loiret.

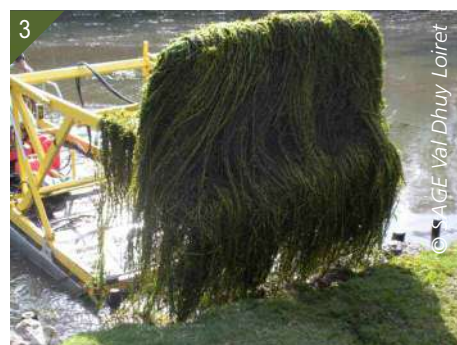
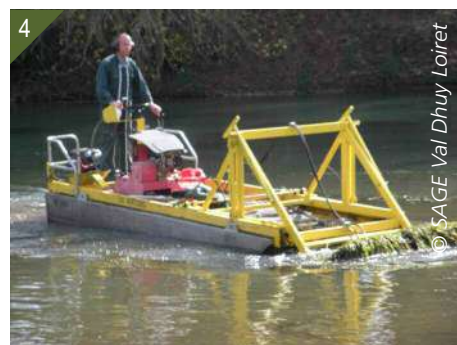
3. 4. The motorised, hydraulic rake (Ratodo).

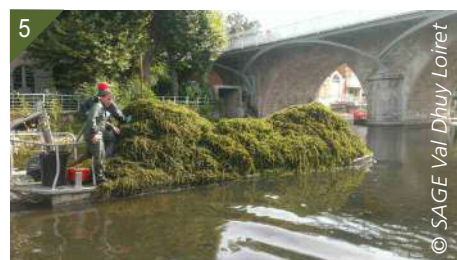
5. Plants loaded onto an oyster-fishing barge.

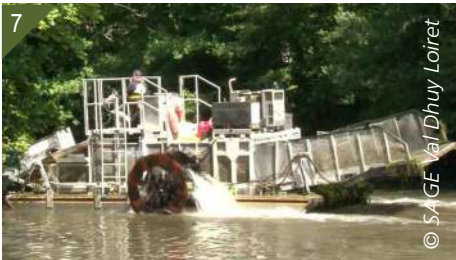
7. Harvester boat.

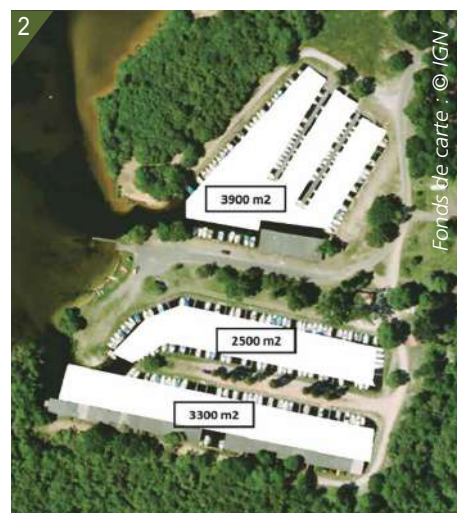
2. The white areas are the basins of the port in the town of Sainte-Eulalie, where the screens were placed.

■ The screens (Soltis part number Serge Ferrari 86-2053) are micro-perforated to enable the passage of gasses produced in the water column by fermentation in the sediment (<http://www.sergeferrari.com/protectionsolaire/gamme-protection-solaire/>).

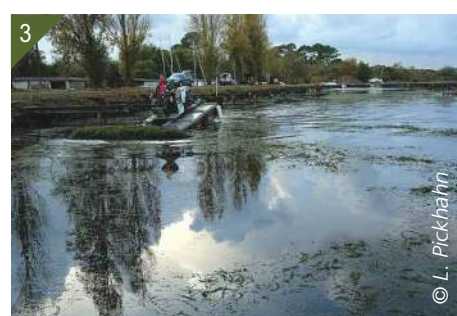
3. The Mobitrac amphibious device.

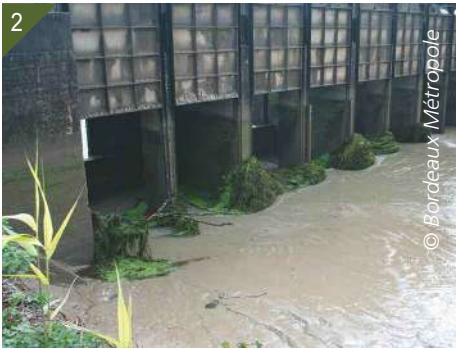
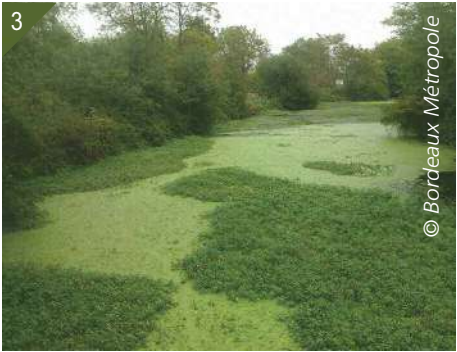
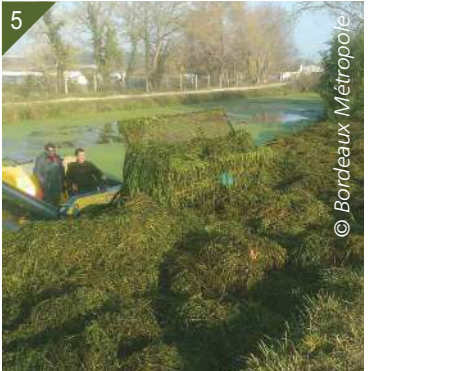
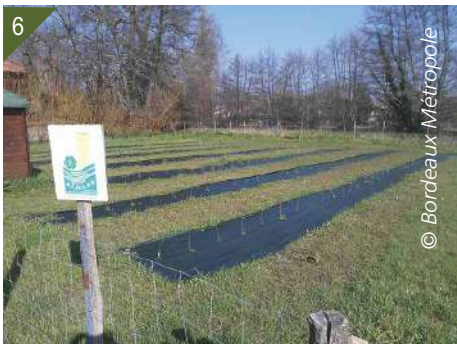
2. Waterweed clogging a hydraulic installation.  
3. The Jalle River colonised by Egeria densa.  
4. The machine used to uproot the plants.  
5. Uprooting the waterweed.  
6. Young trees growing at the SIJALAG nursery.

- Following this work, the occupation indices for waterweed increased downstream, which probably means that the work caused the dispersal of plant fragments.
- Given the ineffectiveness of the mechanical uprooting, its cost and impact on the rest of the ecosystem, it was decided not to continue with the technique.

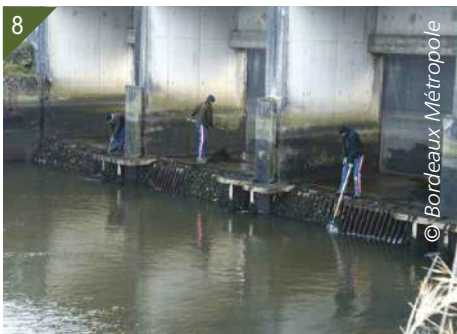
7. Trees planted along the Jalle.  
8. Work to remove E. densa from the hydraulic installations.

- The waterweed (plants and fragments) is removed from the hydraulic installations each year in the fall.
- A total of four to five tons of fresh waterweed are removed each year. The plants are spread on the banks of the river (above flood level) to decompose.

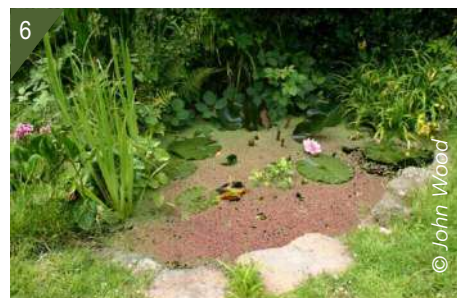
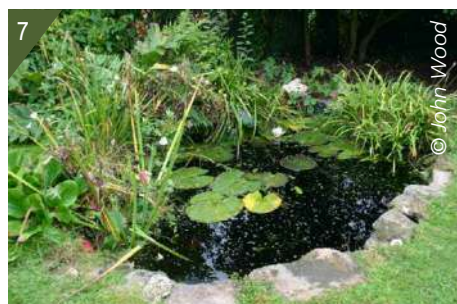
6. 7. A pool in England colonised by water fern before (a) and after (b) the introduction of *Stenopelmus rufinasus*.

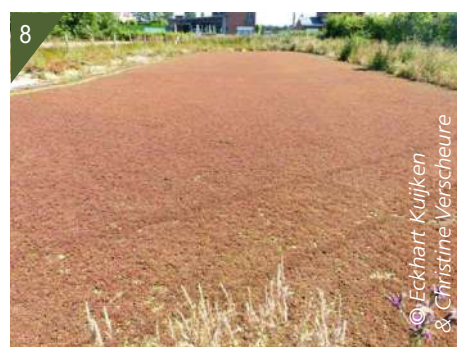
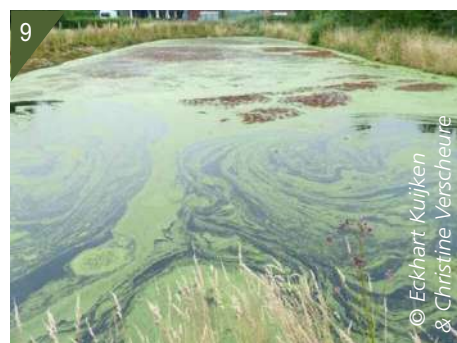
8. 9. A pond in Belgium colonised by water fern before (a) and after (b) the introduction of *Stenopelmus rufinasus*.

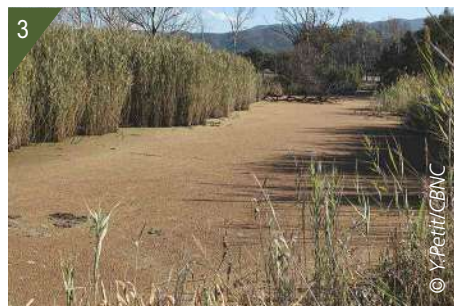
3. Colonisation of the Régina River by *Azolla filiculoides*.

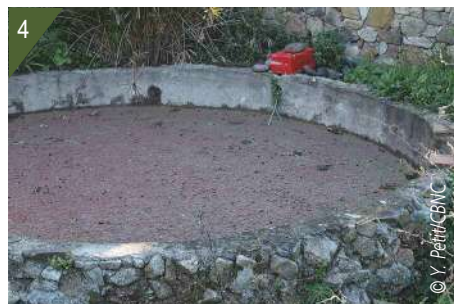
4. Initial condition of the pool in Lumiu.

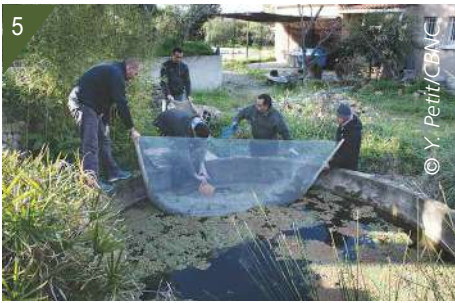
5. Setting up the mosquito net for the pool in Lumiu.  
6. Collecting fragments of water fern with a dip net.

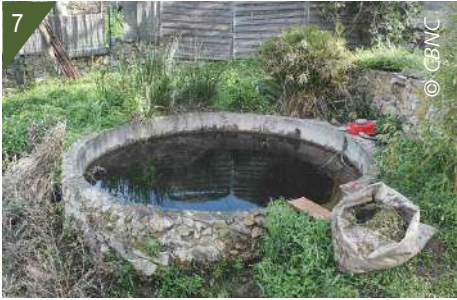
7. The pool in Lumiu following the work.

- In Lumiu, one 80-litre bag and half a second bag were filled during the work in 2015. The owner of the pool may also have removed some plants that were not removed during the work.
- No information on the quantity of water fern collected in Belgodère was available.
- The project was a success on the two sites and to date, no water fern has been observed in Lumiu or on the Réginu River.

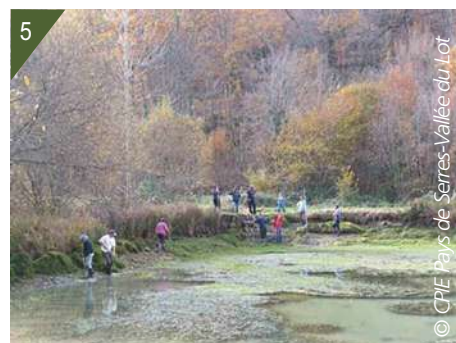
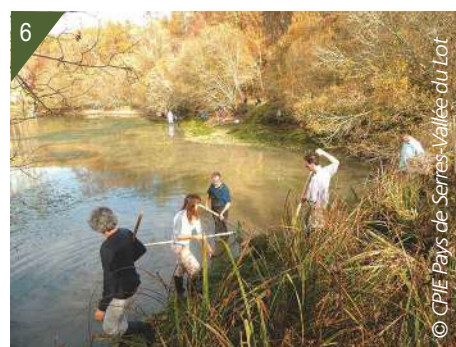
5. 6. Volunteers manually uprooting the plants.

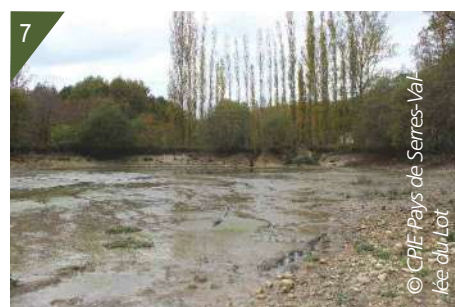
7. The pond and waterweed in November 2016.  
8. Press article published in the Sud-Ouest newspaper in March 2016.

■ During the summer of 2016, the pond dried partially and most of the curly waterweed died, but the incoming groundwater maintained the humidity in a few small spots where the species survived. In these areas, the very thick mud made it impossible to uproot any further plants.

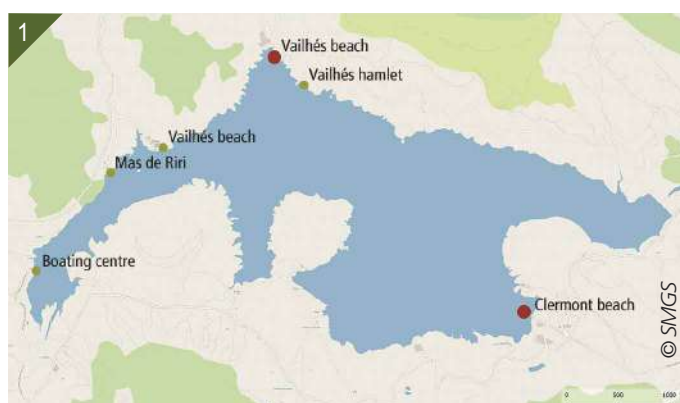
1. Sites where work on curly waterweed was done in the Salagou reservoir in 2014.  
2, 3. Beds of curly waterweed in the Salagou reservoir.

- This technique was used for the Clermont beach from 2013 to 2017 and in the Vailhès bay from 2013 to 2016.
- The company used a harvester boat that collects the plants immediately after they have been cut. The maximum cutting depth was three metres.
- A net was installed around the work zone to avoid the dispersal of plant fragments.
- Each year, the surface area harvested depended on the local conditions, the water level and the development of the plant beds.
- The company also handled the plant waste produced by the work. Following temporary storage to dry the plants, the waste was sent to the composting unit of the nearest civic amenity site.

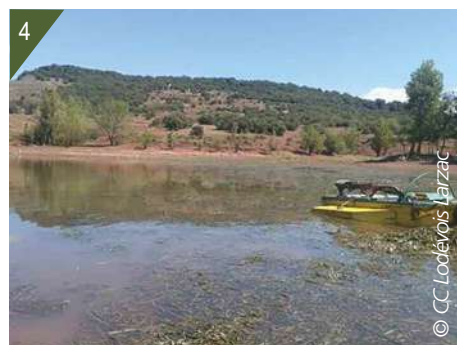
4. Harvester boat.

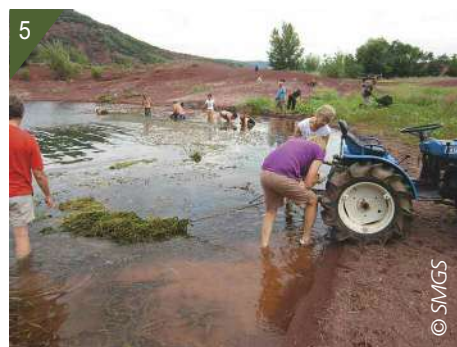
5. A test on dragging the plants using a cable.

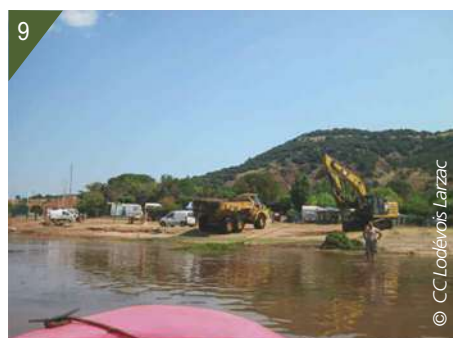
9. The excavator in action.

■ The work was done from the bank by an excavator equipped with a special scraper blade. The collected plants were placed in a dumper. The plants were initially deposited near the reservoir to dry and were then sent to a nearby field, owned by the town of Lodève, for composting.

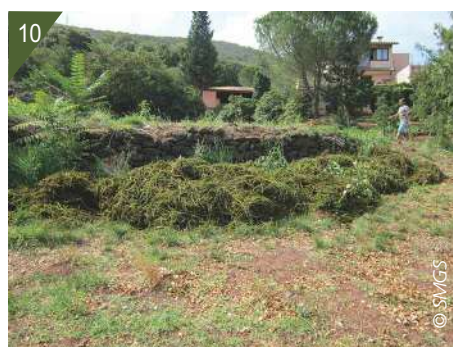
10. Curly waterweed deposited to dry.

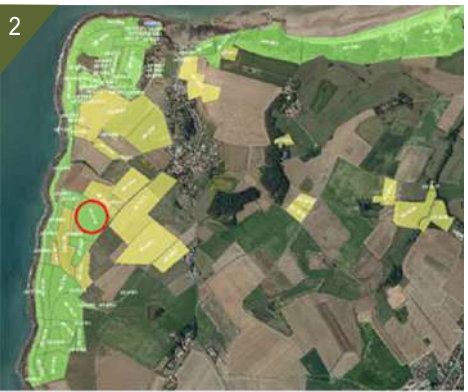
1. Map showing the position of the site.  
2. Land cover on the cape with the pools colonised by New Zealand pigmyweed circled in red.

■ The plant was observed in five pools, located near each other and toward the northern edge of the bomb-hole meadows.

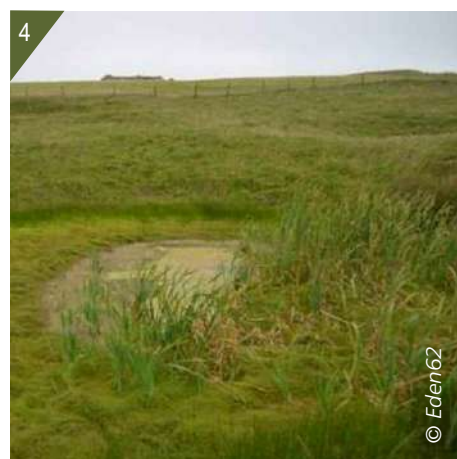
4. Pool colonised by New Zealand pigmyweed.

■ These techniques were not implemented due to a number of technical difficulties. The strong wind on the site made it impossible to lay tarps and the accumulation of rain water in the centre of the tarps was also a problem. Manual uprooting was not deemed possible given the large quantities of N.Z. pigmyweed to be removed.

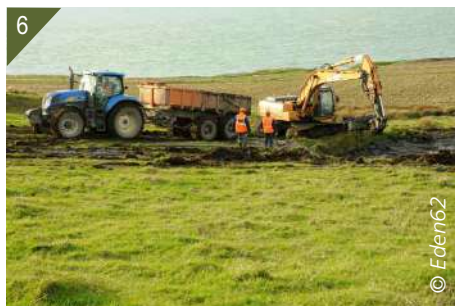
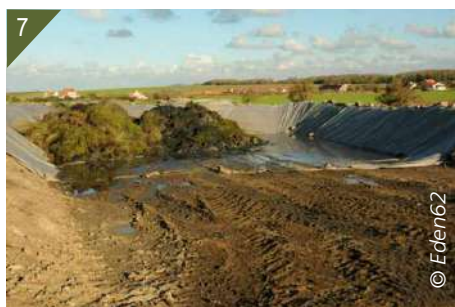
5. Filling in of a pool caused by New Zealand pigmyweed.

6. Dredging one of the bomb holes.

- A total of 600 cubic metres of soil and plants were removed.
- The surface area freed by the work represented approximately 1 000 square metres.
- In 2015, N.Z. pigmyweed was again observed in the five pools that had been dredged, i.e. 20 to 30% of the surface areas dredged in December 2014 were again colonised in July 2015 along the edges of the pools, essentially in the water.
- But no other pools were colonised in the meantime.
- The amphibians continue to use the pools during the reproductive periods.
- Following the dredging, the pools regained their original appearance, i.e. that of craters caused by bombs.

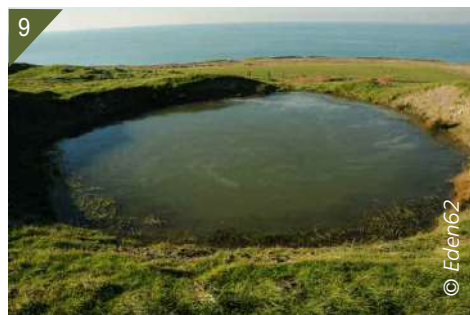
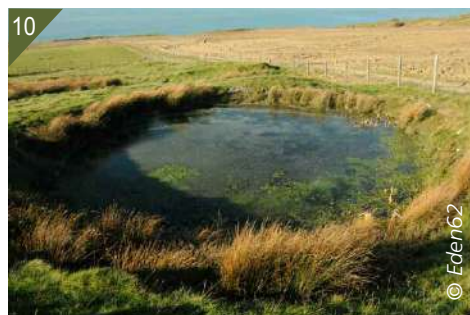
9. 10. Pools again colonised by New Zealand pigmyweed in January 2016.

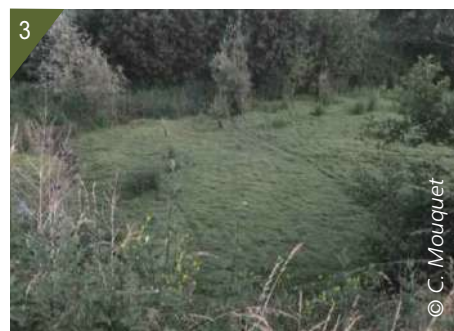
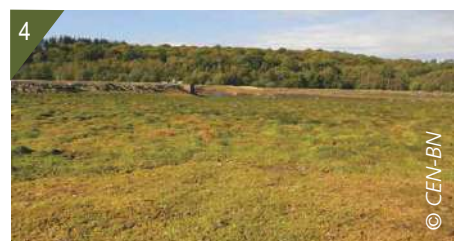
3. The side channel colonised by New Zealand pigmyweed.

4. The Gast pond (Manche department) colonised by New Zealand pigmyweed.

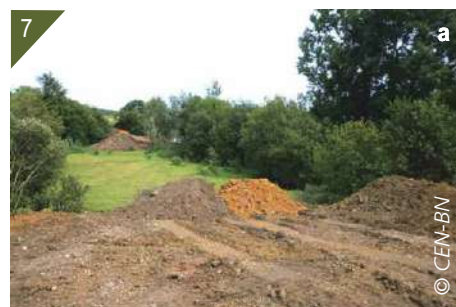
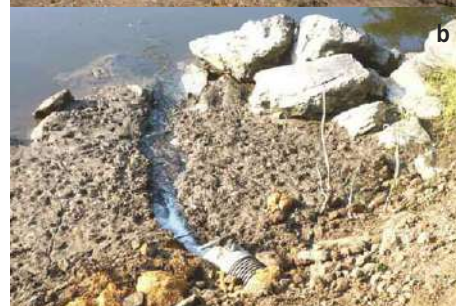
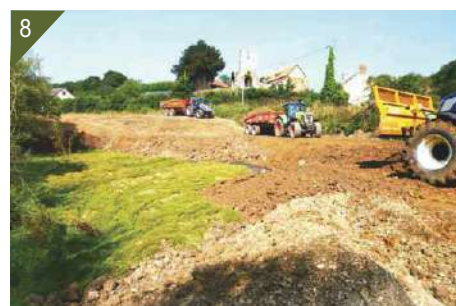
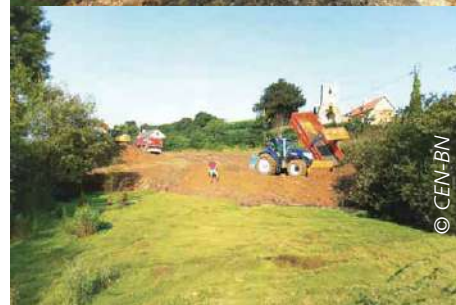
6. Diagram showing the work on the site.

7. a) Creating the dike and b) installing the culvert.

■ The entire surface area (1 700 square metres) of the side channel was filled in with on-site deposits and material excavated during work on the sewer system in the town of Meauffe.

■ Prior to the filling work, the water level of the Vire was lowered to facilitate the reinforcement of the dike.

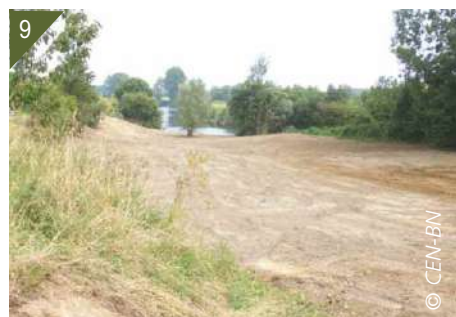
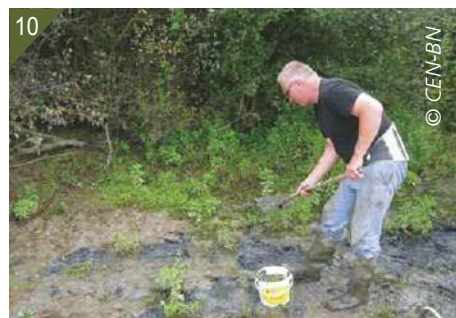
9. The side channel at the end of the work.  
10. Manual scraping of colonised areas.

■ No NZP regrowth has been observed since the work. Ruderal species are now growing on the site.

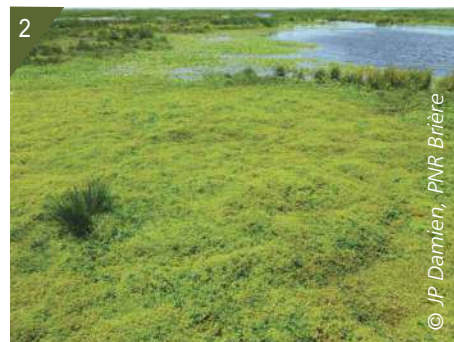
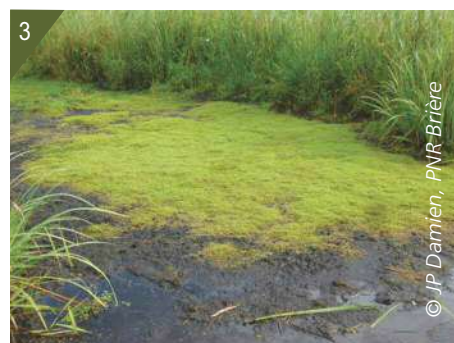
2. New Zealand pigmyweed in a meadow near a water body.

3. Pigmyweed on a mud flat.

■ A total of 153 stands of pigmyweed were found, i.e. eight times more than in 2015, ranging from dense beds covering several hundreds of square metres to single, isolated plants, representing a surface area of 40 300 square metres.

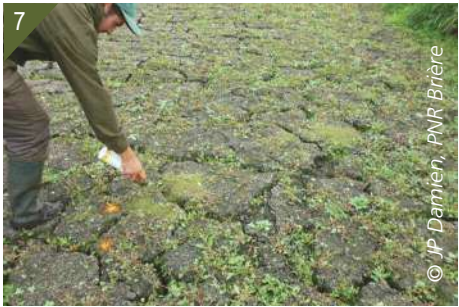
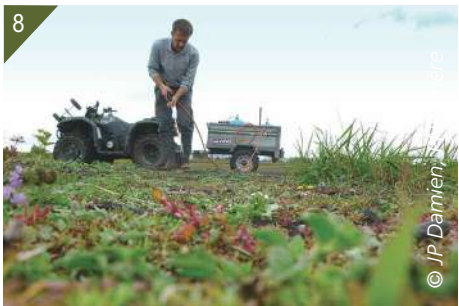
*6. Map showing the inventoried areas (in blue) and the stands of New Zealand pigmyweed (in red) in 2016.*

*7. Identifying the plants prior to the work.*

■ In the Pierre-Constant reserve, 56 stands were identified (consisting mainly of dispersed beds covering a total of 11 410 square metres, though one bed covered 120 m<sup>2</sup>) and 53 stands were treated. No work was done on the three stands along the western edge of the reserve due to large potential sources of propagules in the immediate vicinity and their position in a reed bed, which would have complicated the work. Stakes were planted near 35 plants for monitoring purposes.

■ Along the Trignac Canal, 27 stands were identified, representing a total surface area of 8 800 square metres (4 220 m<sup>2</sup> of dispersed beds, 3 440 m<sup>2</sup> of fragmented beds and 1 140 m<sup>2</sup> of continuous beds). One bed on the northern side of the canal was not treated due to a problem with the gas supply (the number of remaining beds did not justify a return trip to the site).

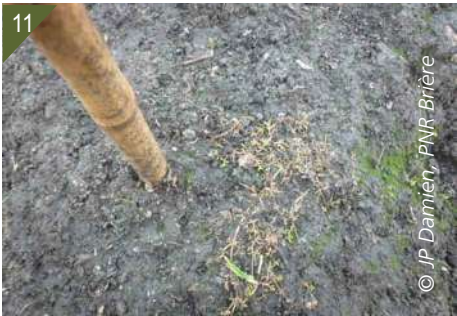
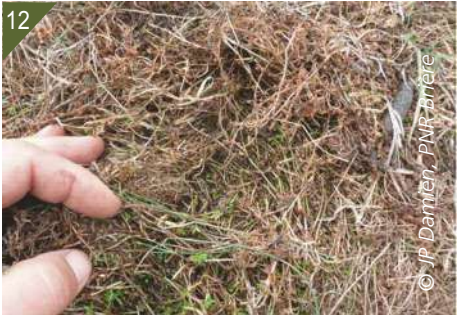
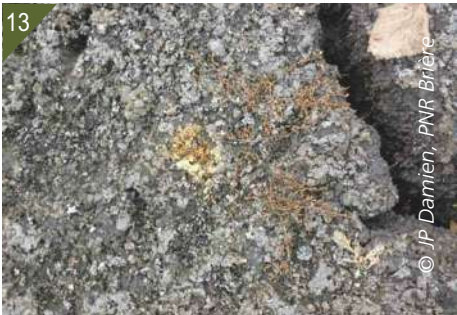
11. Living parts of treated plants.  
12. Dead upper parts of plants, but lower parts still alive and green.  
13. Dead plants that had poorly developed prior to the work.

- Three weeks after the work, initial observations were made on the marked plants:
  - in the Pierre-Constant reserve, no completely dead plants were observed. All the marked plants still had at least one living branch or section. In the area with a continuous bed, the upper parts of the plants were dead (dry), but the lower parts close to the ground were still green. A few of the unmarked plants were dead. New plants were also observed;
  - along the Trignac Canal, no monitoring was carried out in 2016 due to the difficulty of accessing the site and insufficient resources. The effectiveness of the work will be assessed in 2017.

- The test revealed a number of difficulties in organising the work during the most favourable periods. On the basis of the initial results, thermal technique would appear to be fairly ineffective. It is difficult to work on 100% of the plants in an area because they are difficult to locate when highly dispersed. This fact hinders any selective management of the plants (e.g. manual uprooting) targeting the initial establishment of the species. Their growth is spread over time, meaning that a single passage is not sufficient to eliminate all the potential shoots.
- Further evaluation of the results will be carried out in 2017 with at least two passages planned in the treated zones. New Zealand pigmyweed is one of the species targeted by the annual inventory of invasive alien aquatic plants that will be carried out again in 2017.

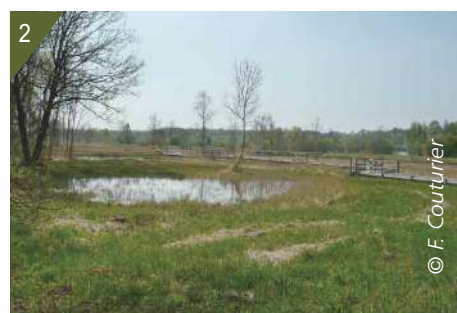
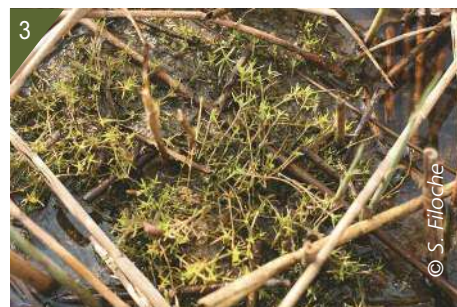
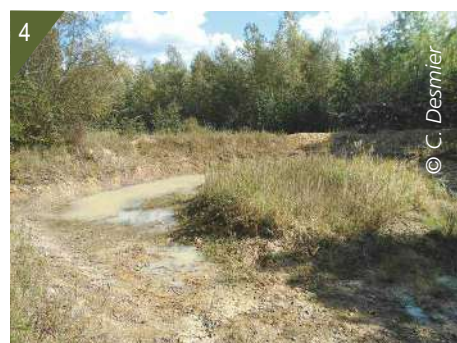
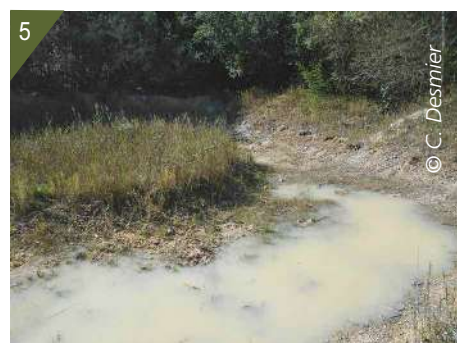
2. The Épisy marshes.  
3. Pigmyweed seedlings in a wet area.  
4, 5. The site in 2017.

- During the initial uprooting work, a total of one cubic metre was collected, including pigmyweed, dirt and reed rhizomes that were difficult to disentangle.
- Following the summer of 2007, no regrowth was observed during the monitoring visits.
- In 2017, the site was again revisited and no pigmyweed was observed. However, the site had been modified. The low, wet area had been dug out and there was an island in the large pool.

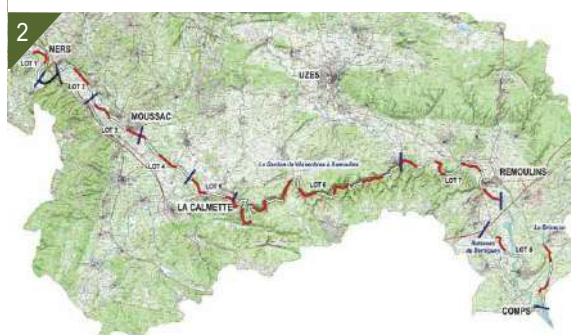
1. Presence of water primrose in the Gardons basin in 2015.  
2. Sites where work on water primrose was done in 2012.

- In 2013, the tributaries to the lower Gardon were withdrawn from the project because the low colonisation levels did not require comprehensive management. They were subsequently monitored and uprooted on a less regular basis. The project continued in seven sectors spanning a total distance of almost 50 km of river between Ners and Remoulins (along the Gardon River and a gravel pit, see Figure 2).

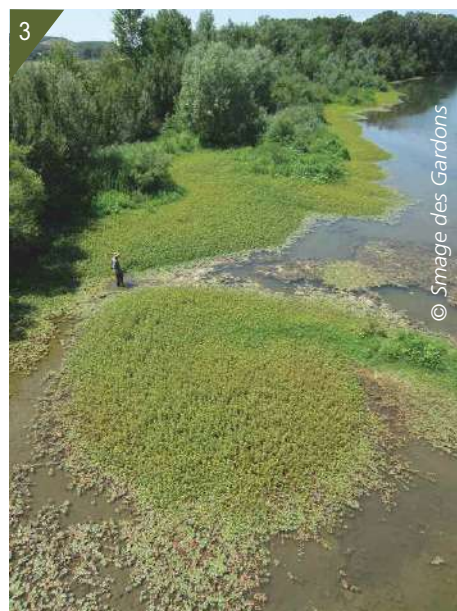
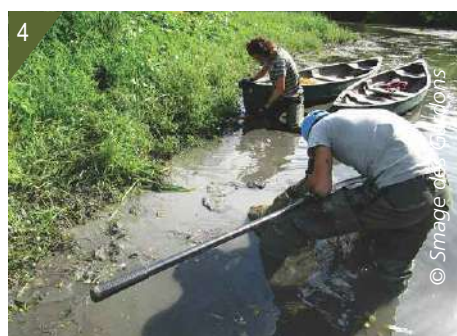
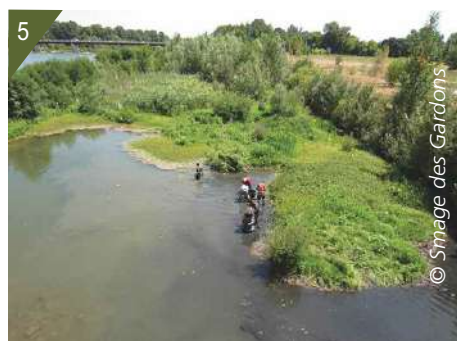
3. An area colonised by water primrose.  
4. 5. Manual uprooting.

- Manual uprooting was pursued along these 50 km over the three-year period (2012-2014).
- Each year, the work lasted approximately five months from June to October. The initial plan was for a single uprooting period, but in 2013, the technical specifications were modified to include two passages through each area, one in June-July and the second in August-September. The second was deemed

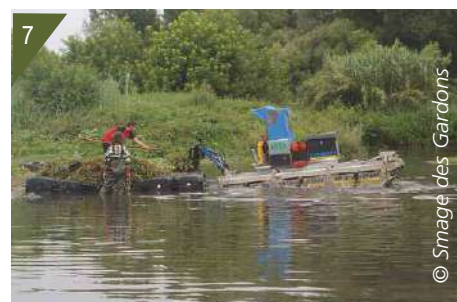
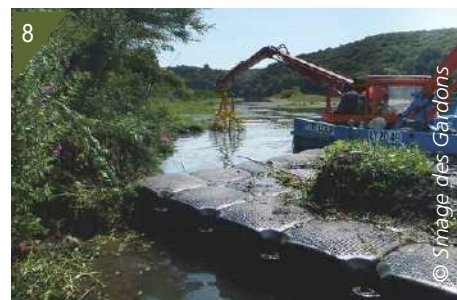
7. 8. Mechanical uprooting with the harvester boat and the raft used to remove the harvested plants (Figure 7), and the boat with the crane and the raft (Figure 8).

■ The company doing the work suggested testing a technique involving hydraulic dredging and filtering of the sediment. This experimental technique was used during the second (summer of 2013) and third (February-March 2014) uprooting campaigns:

- the boat with the crane was equipped with a suction head and a shredder;

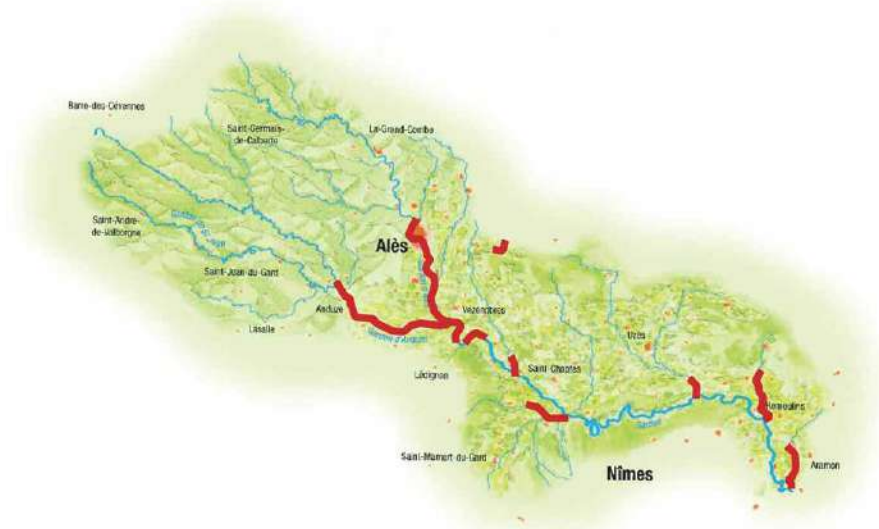
Map showing the river sections monitored annually.

- Each year since 2013, 60 kilometres of river have been inspected.
- This work limits the risks of seeing the areas colonised by water primrose grow, while also ensuring the early detection of the other targeted species.

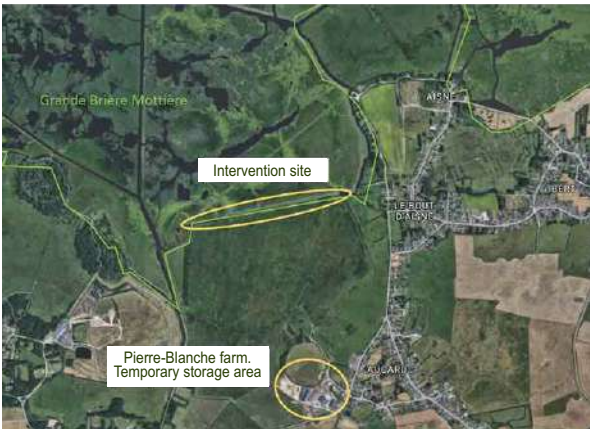
Intervention site. The lighter green areas in the meadows are the water primrose.

- The water primrose was present in abundance in and along the canal. Over a distance of 700 metres, it occupied over 90% of the water surface area and over the remaining 150 metres, it covered an area one to two metres wide along each bank. It had also invaded the nearby meadows and water bodies.

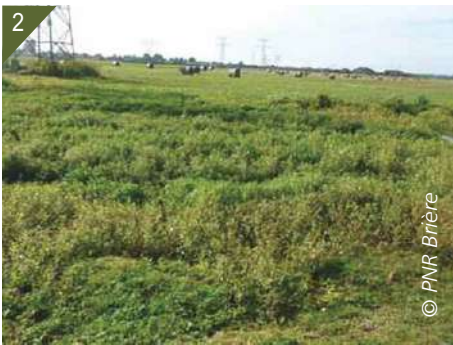
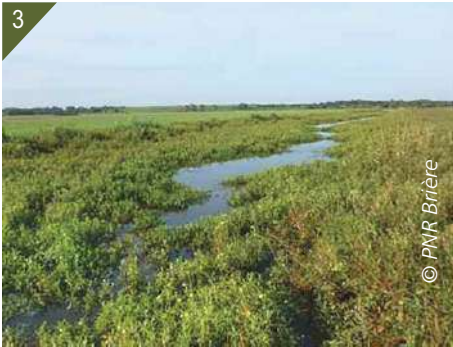
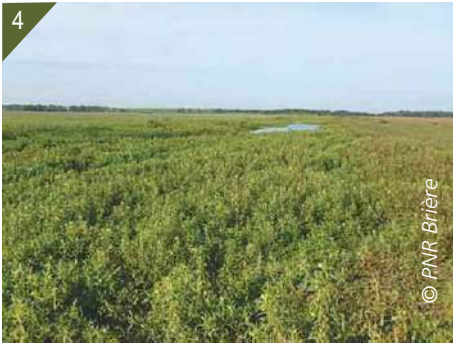
2. 3. 4. Canal full of water primrose prior to the work.

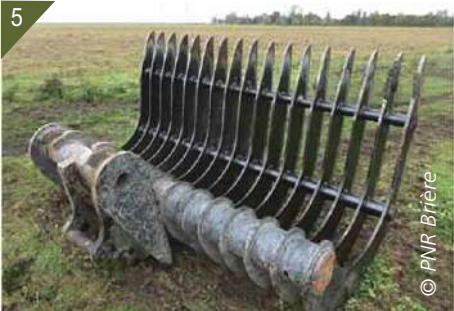
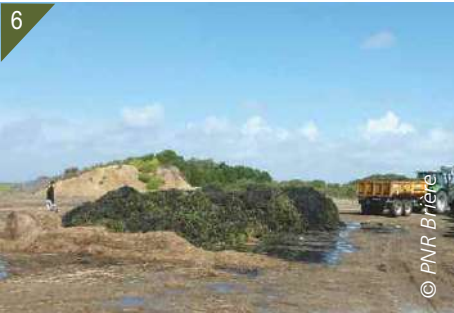
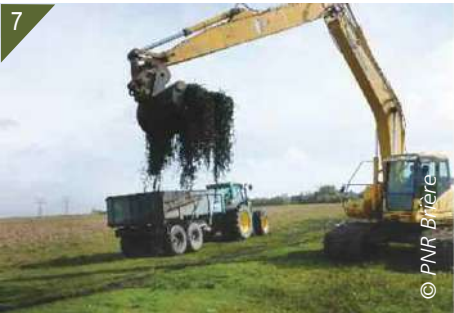
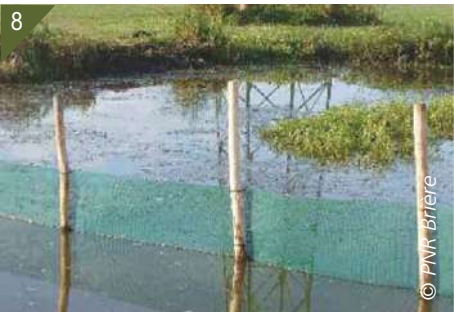
5. The fork used to uproot the plants.  
6. Temporary storage of the water primrose, surrounded by hay.  
7. Removal of the water primrose.  
8. Barrier across the canal to filter fragments.

- The work took place from 15 September to 2 October 2015 in order to take advantage of the better (drier) soil conditions.
- The plants were uprooted by an excavator equipped with wide treads and a special fork designed to limit the extraction of sediment and water.
- The work did not address the beds on the top of the banks or the mud at the bottom of the canal. Their removal would have involved additional quantities of soil and sediment, as well as excess costs and regulatory constraints imposed by the Water law.

- Depending on the density of the extracted plants, they were either loaded directly into a trailer or first piled on a bank and then loaded. In that water primrose is widely present in that section of the marshes (on and along the dirt road), it was not necessary to lay down tarps to protect the soil and avoid the dispersal of fragments during loading of the plants in the trailers. However, fragments around the loading zone were nonetheless collected by hand.

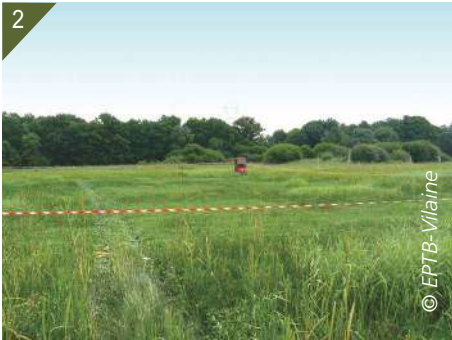
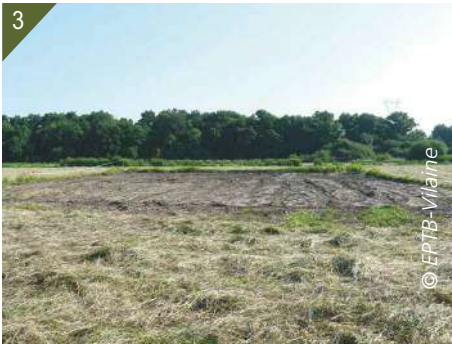
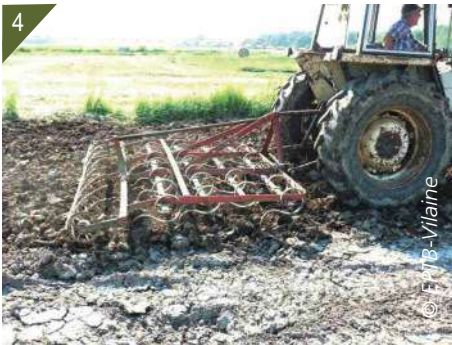
2. The experimental zone prior to the work.  
3. The zone after removal of the topsoil.  
4. The vibrocultivator in action.  
5. 6. The zone just after the work.

- The vibrocultivator was used only once and always lengthwise.

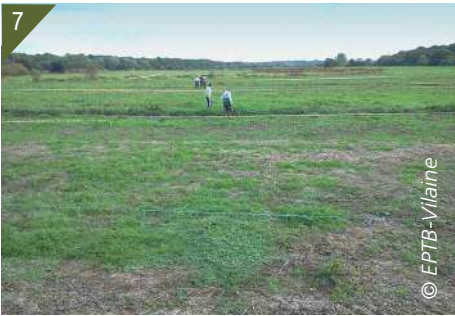
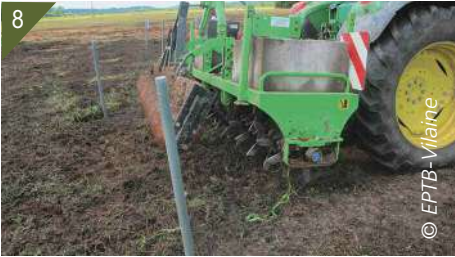
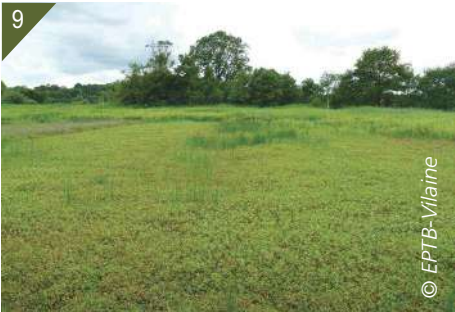
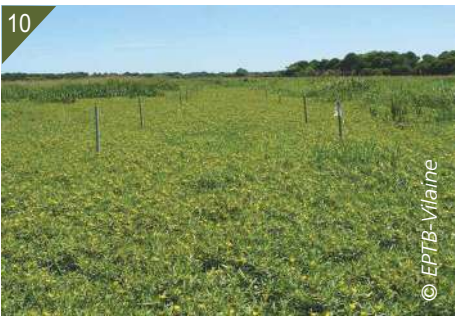
7. Monitoring the results in October 2013.  
8. The actisol soil aerator.  
9. Renewed growth of water primrose in May 2014 in the area treated in 2013.  
10. Renewed growth of water primrose in July 2015 in the area treated in 2014.

- The results of the experiments in 2013 were not satisfactory. Under virtually all conditions and even though some positive results were observed at the end of the growing season with a notable drop in the cover of water primrose, the species grew back strongly (cover rate > 80%) in 2014.

- The results of the experiments in 2014 demonstrated the ineffectiveness of the various operations given that water primrose again covered over 90% of the treated areas just one year after the work.
- The development of fineleaf waterdropwort (shown in blue in the graph) was again noted, as well as that of water knotweed (*Persicaria amphibia*) (in yellow) in the areas with only one passage of the tools.

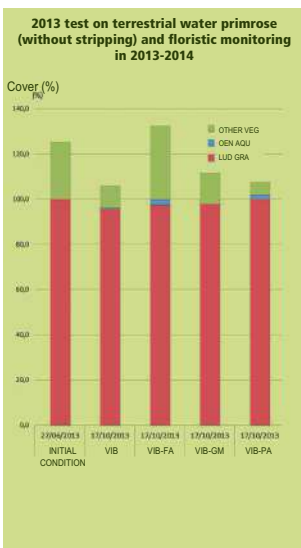
Results of the experiments in 2013.

- The stripping also had an effect on the development of fineleaf waterdropwort (*Enanthe aquatica*) at the end of the growing season and the start of the next. The seed bank of this species would seem to have been stimulated and the more favourable hydric conditions enabled its development.

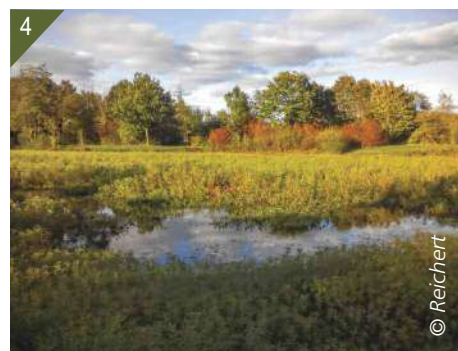
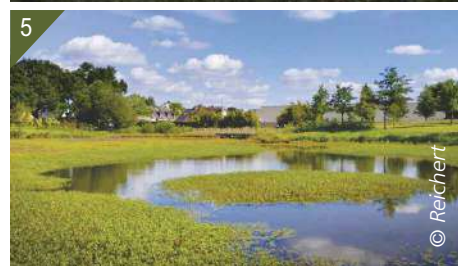
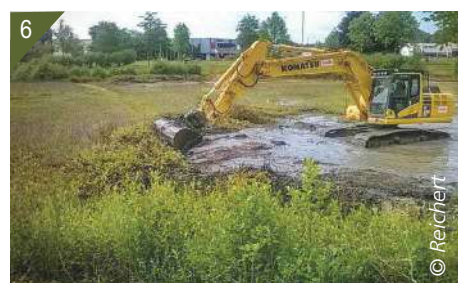
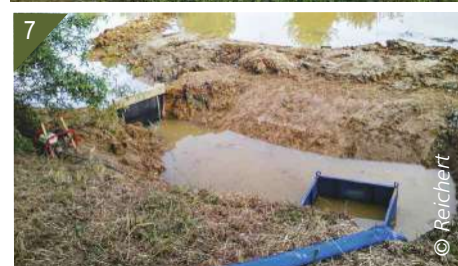
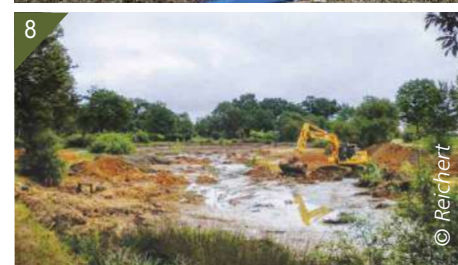
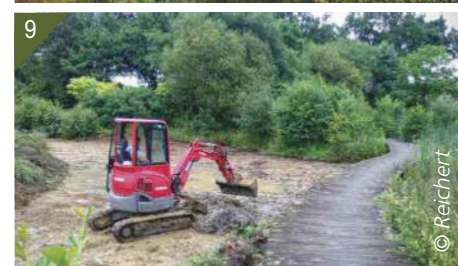
4, 5. Acigné 02 pond, prior to the work.

6. Mechanical uprooting in Acigné 02.

■ Ditches 1.5 metres deep were dug in the middle and along the ponds. The extracted plants, sediment and soil were buried in the ditches and covered with the soil removed while digging the ditches.

■ Pond Acigné 01 was partially filled with 80 cm of mineral soil and 20 cm of top soil. The banks were reworked and a channel dug to lead the water to the overflow system. The pond refilled naturally and very rapidly with 40 cm of water due to the alluvial groundwater flowing in from the bottom of the pond.

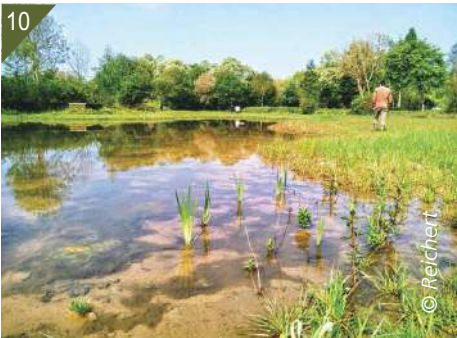
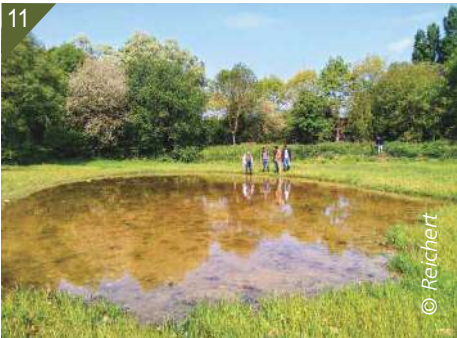
10. Reed bed in pond Acigné 02 (after the work).  
11. Pond Acigné 02 after replanting.

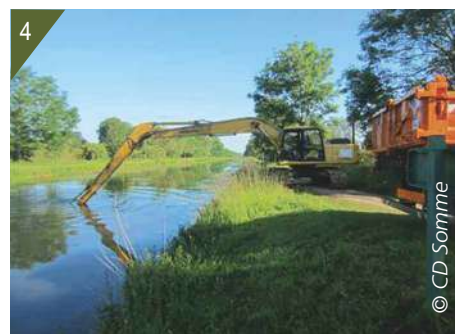
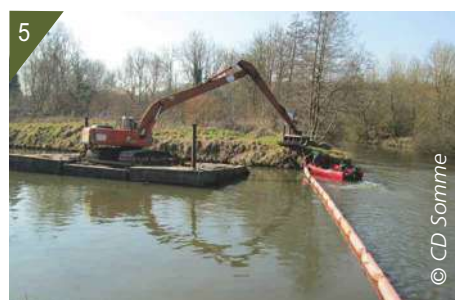
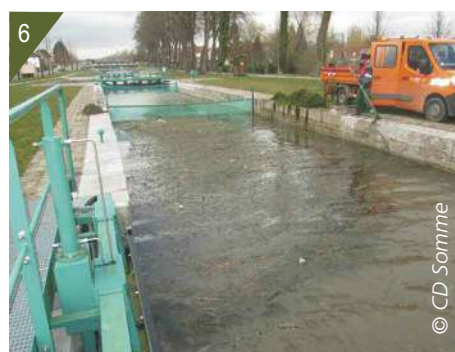
4. Harrowing from the bank.

5. Harrowing from a barge.

■ This technique has the advantage of removing the root system of the plant and avoiding the risk of trapping alevins when pulling the plants onto the bank, however the great weight of the machine may damage the banks, dikes and trails.

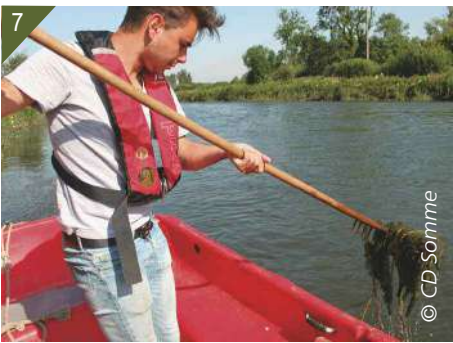
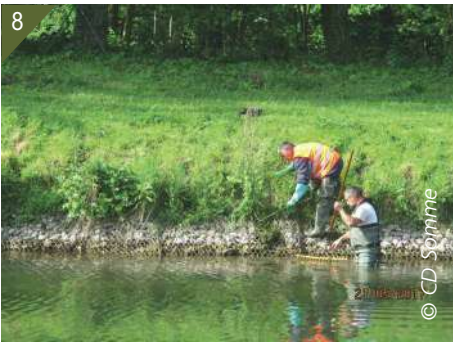
7. Drawing a sample of watermilfoil.  
8. Manual uprooting of broadleaf watermilfoil.

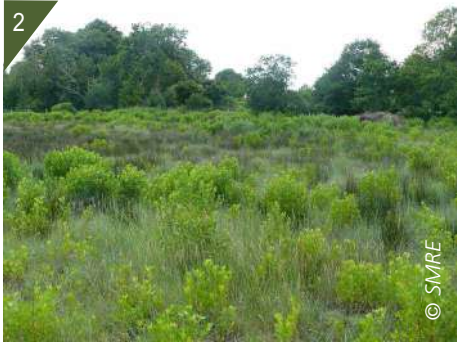
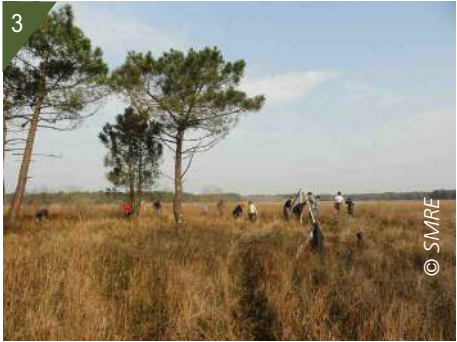
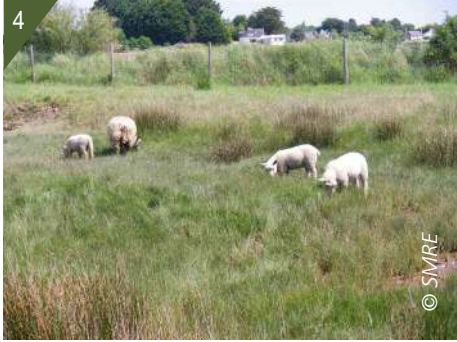
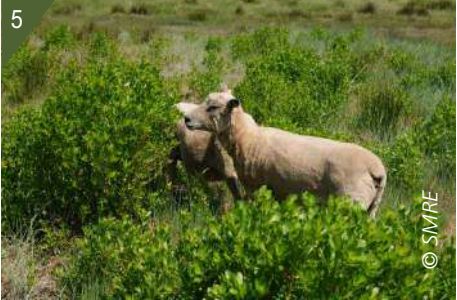
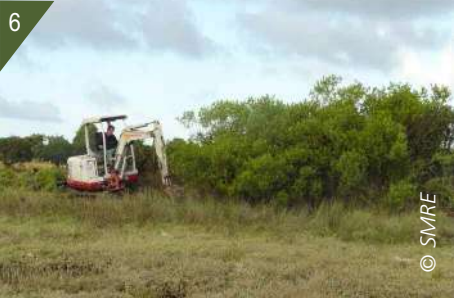
2. Salt meadows colonised by groundsel bushes.  
3. Volunteers during uprooting work.  
4. 5. Grazing by sheep.  
6. Mechanical uprooting.

Work by volunteer groups
Method	<ul style="list-style-type: none"> <li>■ Thickets of adult groundsel bushes (approximately two metres tall) were uprooted by a specialised company using a mini-excavator.</li> <li>■ The bushes were burned on site, in a predetermined area, following a special authorisation by the prefecture of the Morbihan department. Currently, no use for the bushes has been found (a study on grinding the bushes has not produced any solutions).</li> </ul>
Prerequisites	<ul style="list-style-type: none"> <li>■ Metal plates must be placed on the ground to protect the salt meadow from the tracks of the excavator.</li> <li>■ In that the salt meadows are listed in the land register, the prior consent of the land owner is required (signed contracts).</li> </ul>
Equipment	<ul style="list-style-type: none"> <li>■ A mini-excavator on rubber tracks and equipped with a bucket.</li> <li>■ The smallest bushes around the thickets were uprooted by hand.</li> </ul>

Work periods and duration	<ul style="list-style-type: none"> <li>■ The excavator was used over two periods (one person on the excavator and two others for manual uprooting), the first spanned three days in June 2010 and the second five days in June 2011.</li> </ul>
Monitoring	<ul style="list-style-type: none"> <li>■ Photographic monitoring before and after the work.</li> </ul>

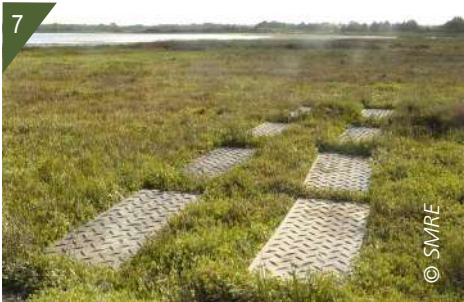
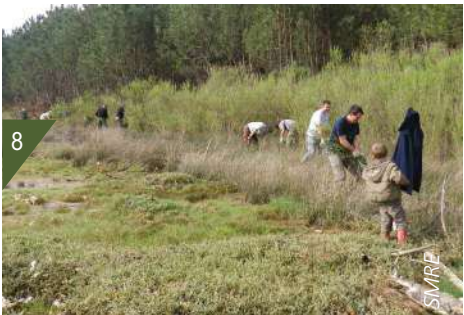
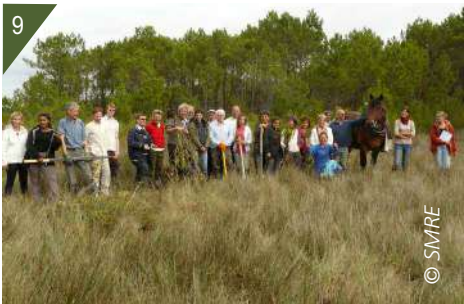
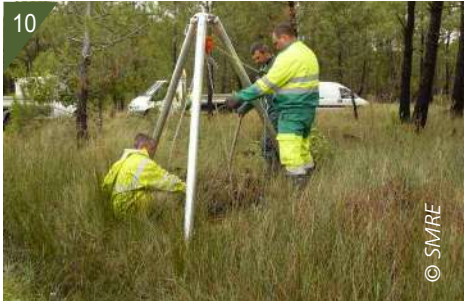
7. Metal plates used to protect the salt meadow when machines are used to mechanically uproot the bushes.  
8. 9. Uprooting by volunteers.  
10. A tripod with telescopic legs, equipped with a chain hoist.

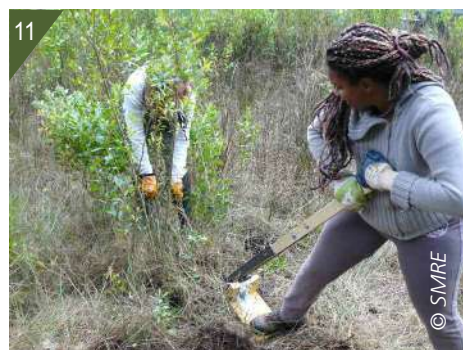
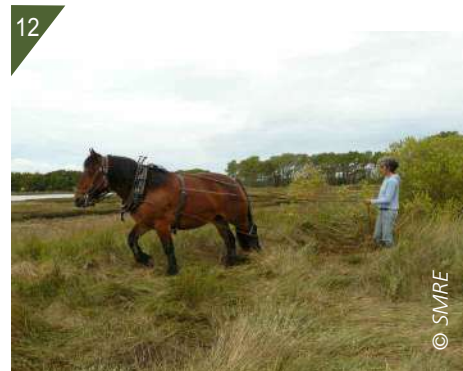
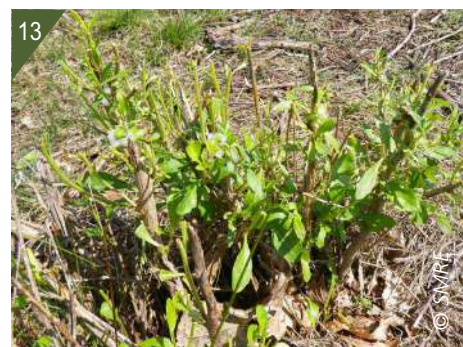
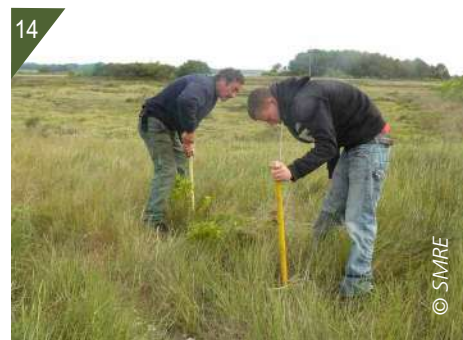
11. Manual uprooting using the "baccharache" tool.

12. Demonstration of uprooting of groundsel bushes using a horse.

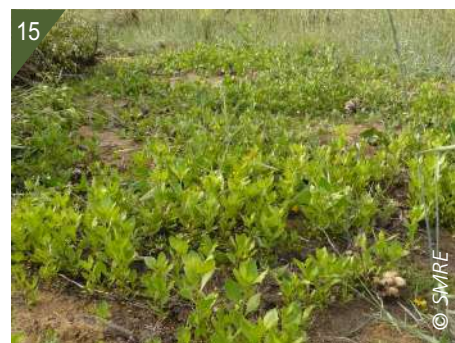
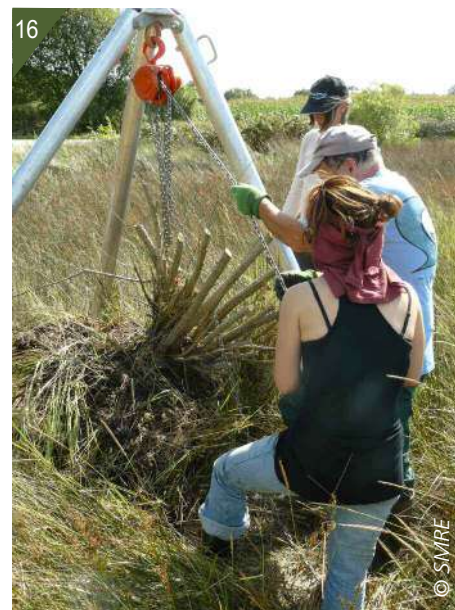
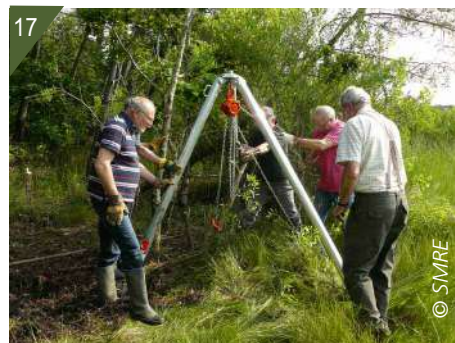
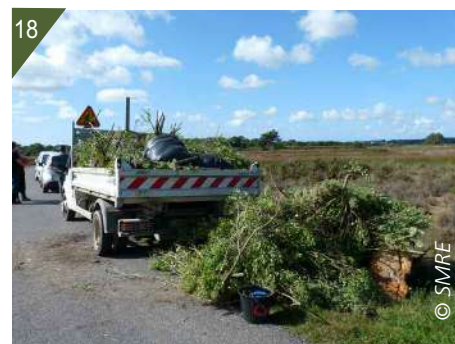
15. Groundsel bushes sprouting after uprooting.  
16. 17. Uprooting of groundsel bushes using the telescopic tripod and chain hoist.  
18. Removal of the waste to an incineration unit using a dump truck.

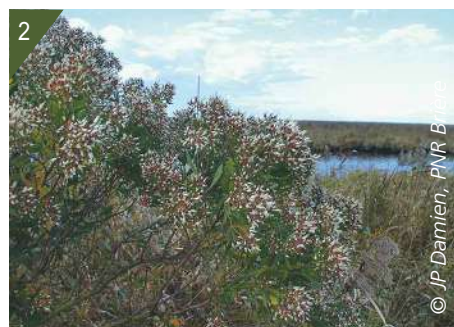
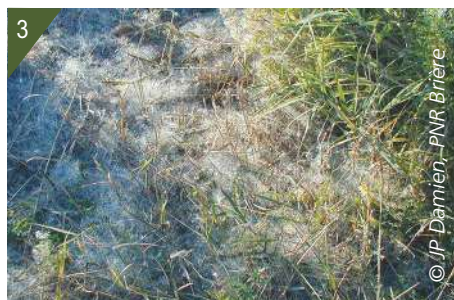
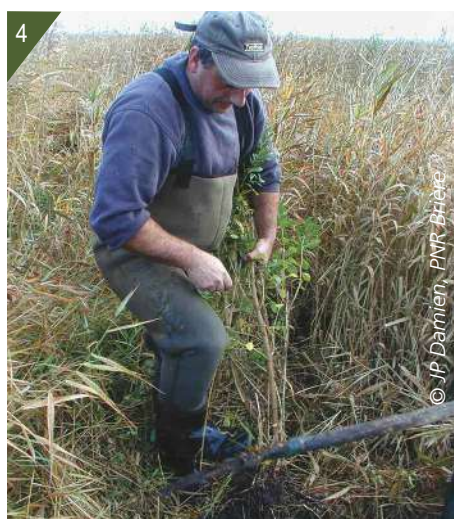
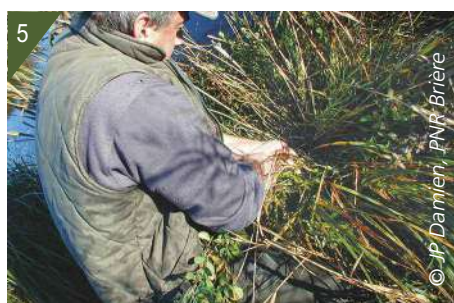
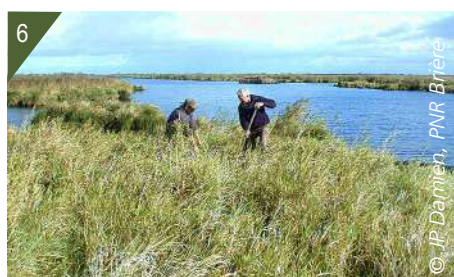
2. Groundsel bushes along the Brière canal.  
3. Groundsel seeds on the ground.  
4. 5. 6. Manual uprooting of young plants.

- The following years, the work was done over a single period, generally in parallel with the work on water primrose in order to take advantage of the joint resources in terms of logistics, funding and human resources. The work is easier at the end of summer and beginning of fall when the bushes are still green and easy to identify.

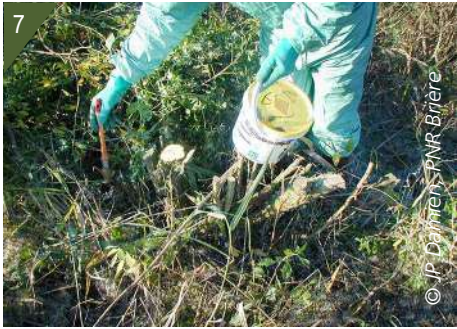
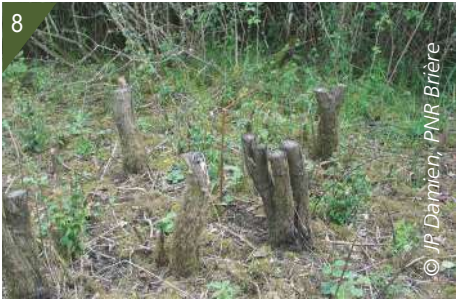
7. Killing a freshly cut stump.  
8. Stumps one year after being cut and killed.  
9. Map of *Baccharis hamifolia* stands in the Grande Brière Mottière marshes, (2007/2008 in purple, 2016 in red).
