## Invasive alien species in aquatic environments

### Practical information and management insights

## Volume 3

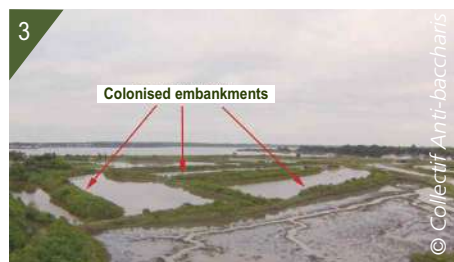
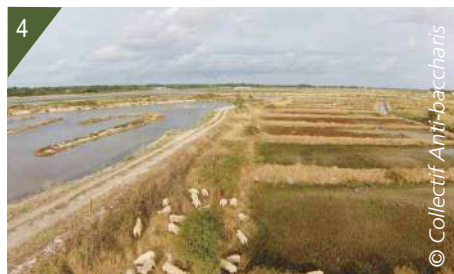
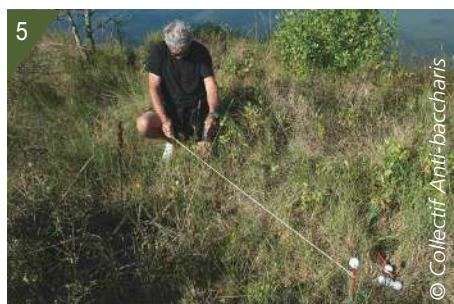
3. Marsh colonised by groundsel bushes.

4. Sheep grazing in the marshes.

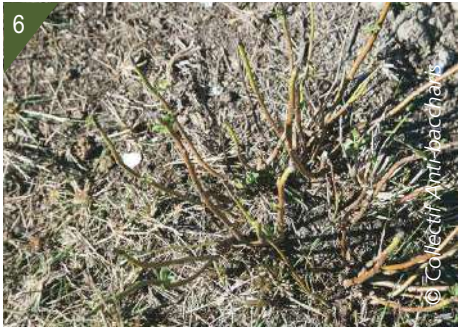
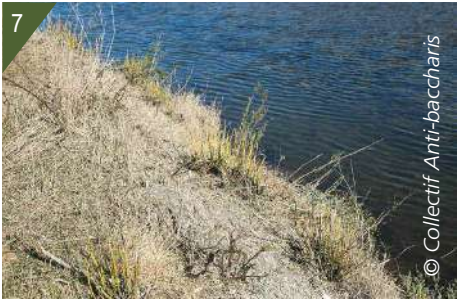
6. Grazed plants without leaves.

7. The sheep also eat the plants on the sides of the embankments.

■ In the areas grazed in 2015, no plants larger than 50 centimetres were observed. Not all the plants had disappeared, but they were weak and had lost their leaves, which limited their flowering and capacity to disperse.

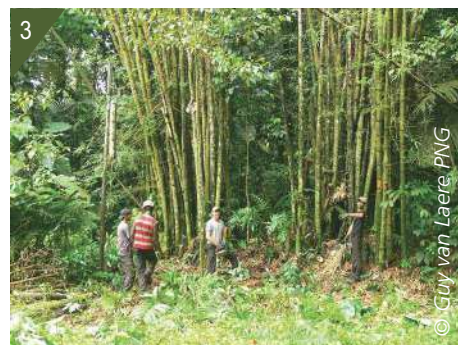
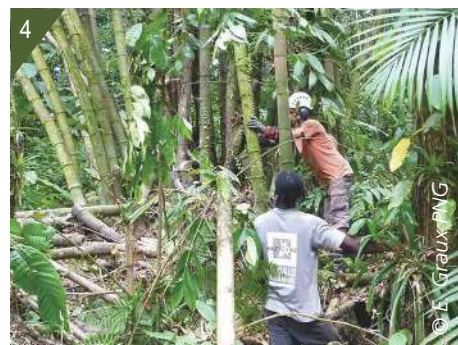
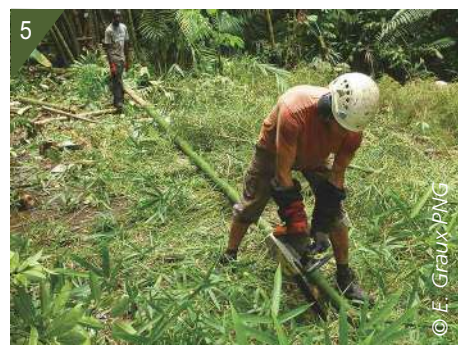
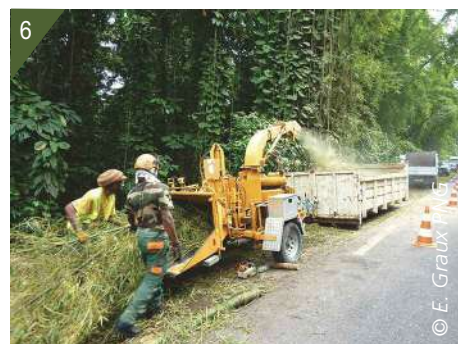
3. A stand of bamboo before being cut.

4. Cutting the stalks.

- cutting the stalks with a chainsaw and removal of the branches. Depending on the local conditions, the stalks were carried out by the men, stored on site for later use or ground on site if they could not be used;
- tarping the stumps that had been cut off at ground level. The tarps covered each stand plus a border area 1.5 metres around the stand.

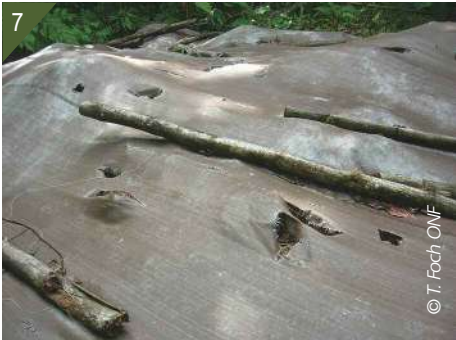
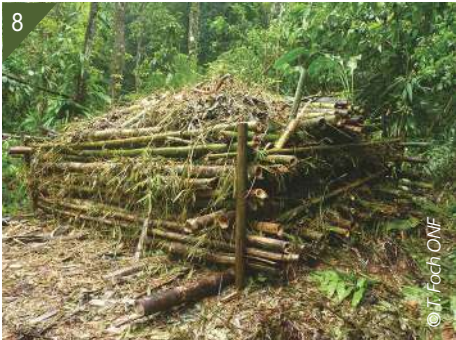
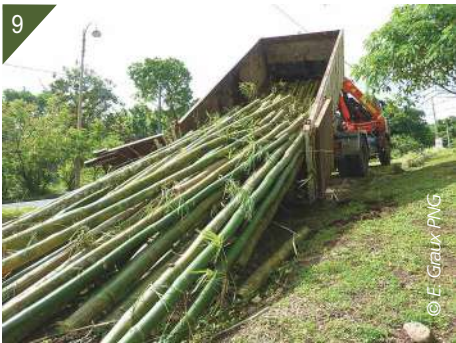
7. A waterproof tarp secured to the ground using metal stakes and nylon cord.  
 8. Raised storage system.  
 9. Green stalks available for reuse.

■ In February 2015, two shoots were noted in a stand on the Piolet site (stand 3) and the Morne à Louis site (stand 16). Shoots were also discovered on the Piolet storage site. They were removed using a machete. No other stands produced shoots and the tarps were removed in 2015.

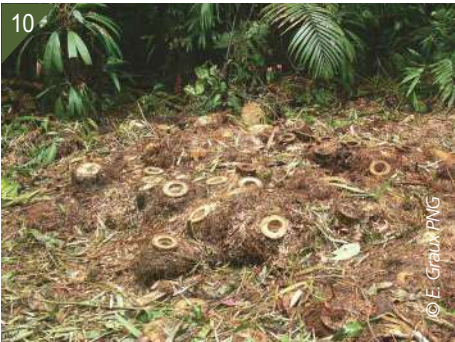
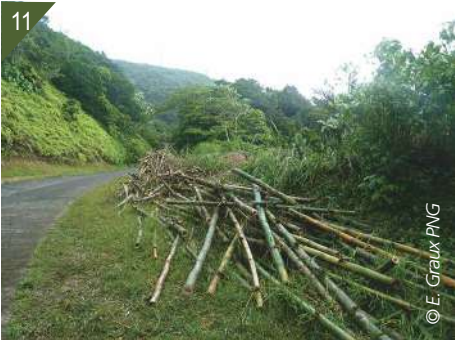
10. A stand after the work.  
11. Stalks stocked along the road.

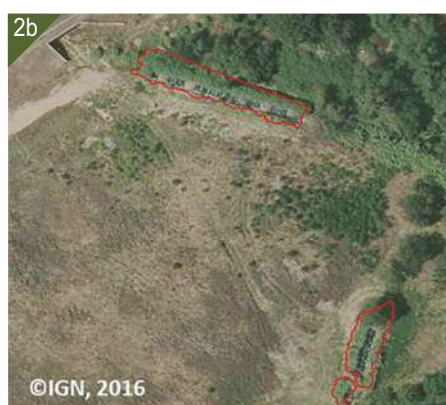
1. Map showing the site.  
2a. 2b. Aerial photos of the site before (2014) and after (2016) the work.

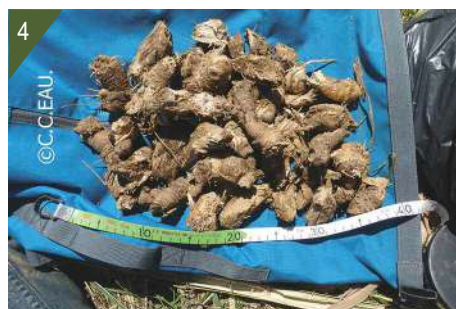
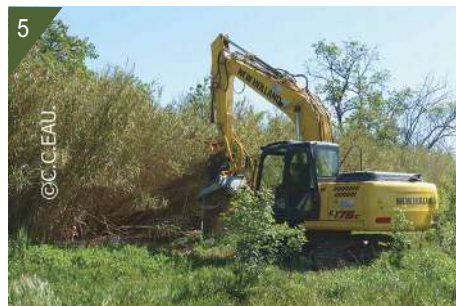
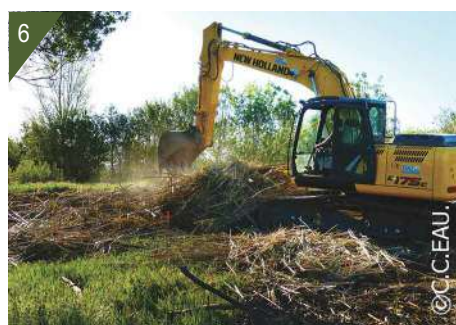
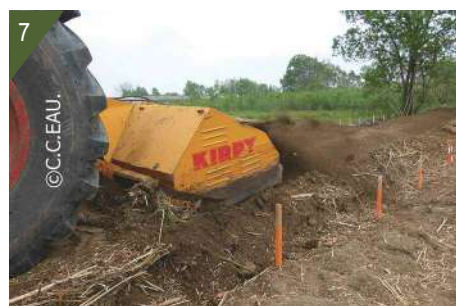
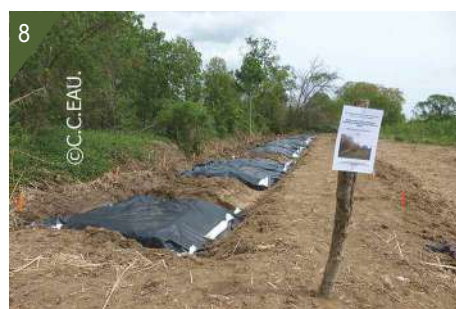
4. Fragmented rhizomes following the first passage of the grinder. Average length = 6.3 cm (SD = 2 cm, N = 150).
5. Clearing the plots using a flail-cutter set up on an excavator.
6. Removal of plant waste after clearing.
7. Soil grinding using a stone grinder mounted on a tractor.
8. Tarped, experimental plots.

- The three pedological trenches revealed:
  - an undulating layer of thick, caespitose rhizomes located at depths of up to 30 cm below the plant litter;
  - a fine and very dense root system descending to the saturated zone located approximately four metres below the ground level of the site.
- Following removal of the plant litter, the soil was ground three times to a depth of between 25 and 30 cm. In each case presented here involving grinding, it succeeded in fragmenting the rhizome layer.

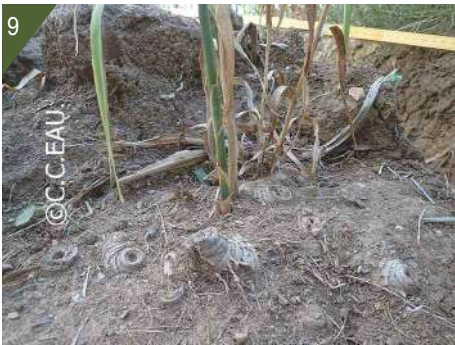
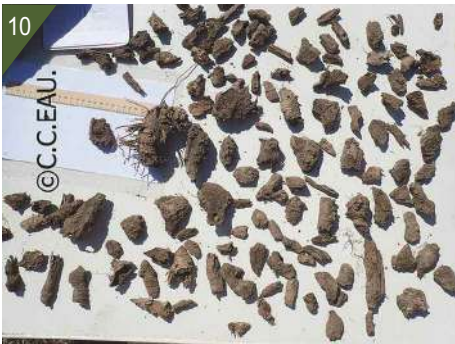
9. After 11 months of tarping, the rhizomes were still alive in a plot that had not been ground.  
10. Dead rhizomes collected in the experimental plots after six months of tarping.

- An investigation of the three plots ground and tarped for six months confirmed the 100% mortality rate among the rhizomes. This is a reliable result in that an average of 307 dead rhizomes were counted per square metre of soil (SD = 126) and no live rhizomes were observed.

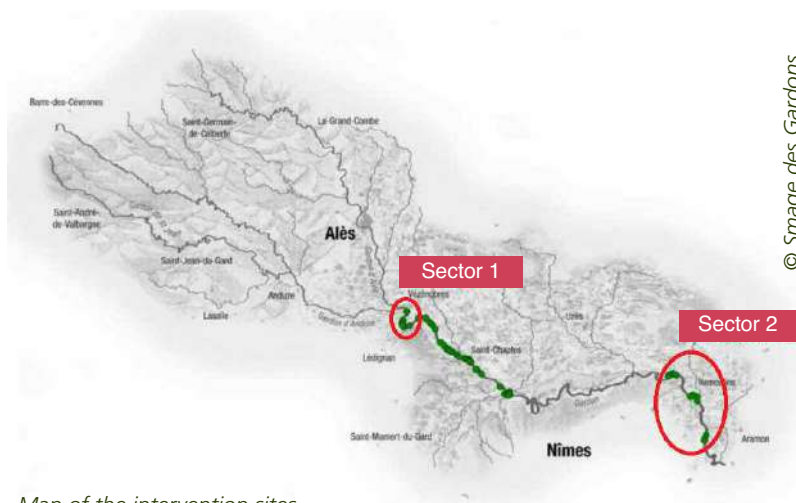
Map of the intervention sites.

- sector 1. The entire upstream invasion front was uprooted over a distance of two kilometres (Vézéobre-Ners), where the plant had colonised small surface areas, in order to study its recolonisation potential following uprooting, in an area where no seeds arrived from upstream;
- sector 2. Heavily colonised areas, located in the downstream section of the river basin, are uprooted using a number of different techniques. The point here was to determine the time required for each technique.

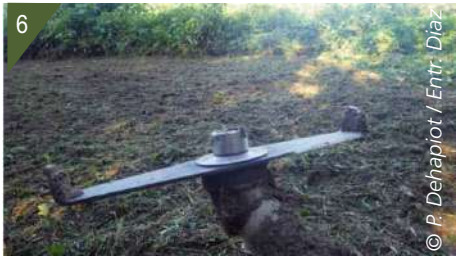
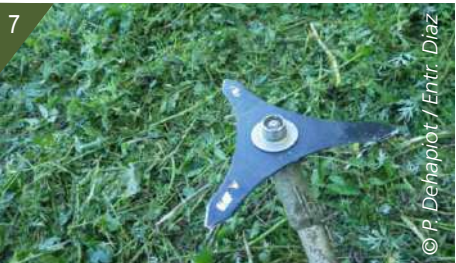
6. A shredder blade and the results in the field.  
7. A cutter blade and the results in the field.

- in the area treated with a shredder blade, the number of new sprouts was negligible and there were no flowers;
- in the area treated with the cutter blade, the hop plants were still present everywhere (though the density was lower than in non-treated areas) and seeds were observed. This technique did not reduce the risks of pollen being released or of seeds being dispersed.

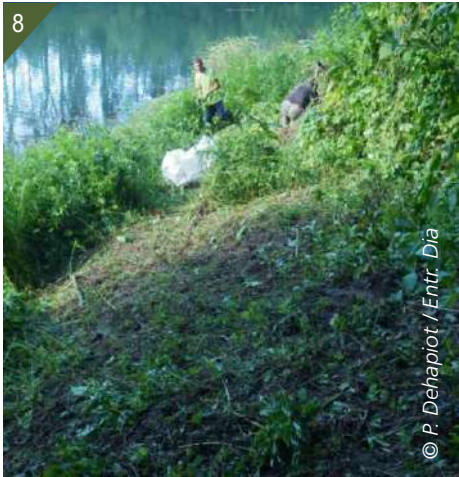
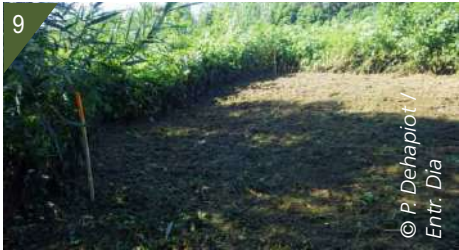
8. Result of manual uprooting on a bank (herbaceous area).  
9. Result of shredding immediately after the work.

Management technique	Sq. metre / person / hour	Hourly cost (not incl. VAT)*	Cost per sq. metre (not incl. VAT)
Manual uprooting 33 hours x 3 people = 340 sq. metres	3.4	35.7	10.4
Cutting (with cutter blade) 1.6 hours x 3 people = 250 sq. metres	55.6	35.7	0.6
Cutting (with shredder blade) 1.5 hours x 3 people = 150 sq. metres	33.3	35.7	1.1

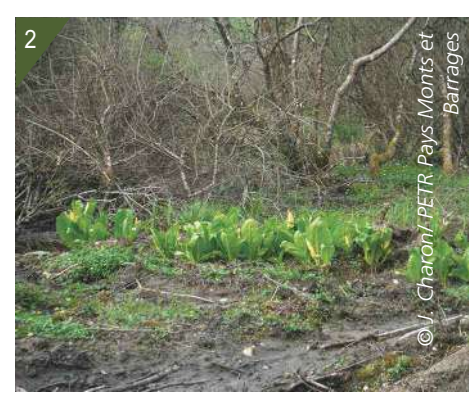
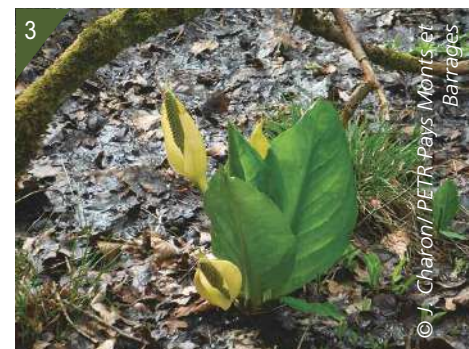
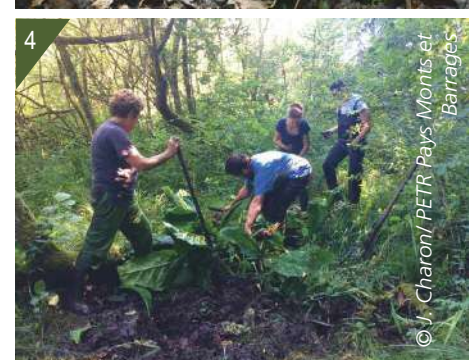
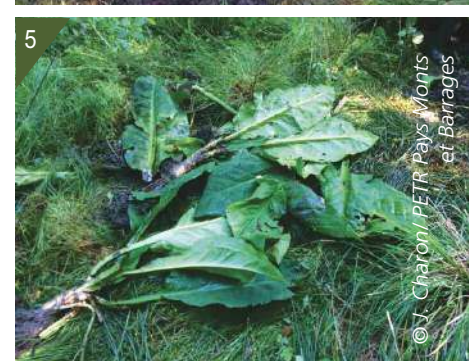
**Step 1.** As a precautionary measure, cut the inflorescences before uprooting the plant.  
**Step 2.** With a spade, dig around the base of the plant to remove the soil until the rhizome is visible.  
**Step 3.** With the spade, cut the roots under the rhizome.  
**Step 4.** Slide the spade under the rhizome and use it as a lever to extract the entire plant. The plants should be deposited nearby, in a dry place, where they will rot.  
**Step 5. (test) :** In the river, sieve the first 5 centimetres of soil (from Step 2) from around the plant to remove a maximum number of seeds before filling in the holes. The purpose of this step is to deplete the grain bank more quickly.

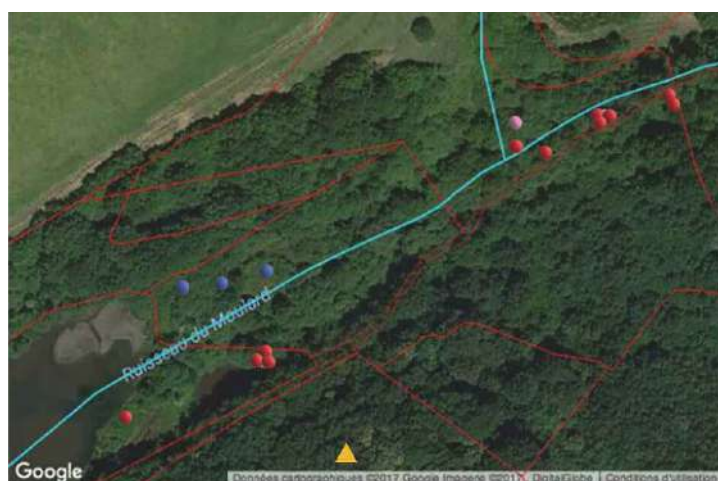
Distribution of *Lysichiton americanus* following the work in July.

- Hydrographic network
- Plants uprooted in July
- Juvenile plants remaining
- Adult plant remaining
- ▲ Deposition zone

- A total of 102 yellow skunk cabbage plants were uprooted in 2017, including 75 during the work in May (representing approximately 0.6 cubic metres of green waste) and 27 during the work in July.
- Five juvenile plants were not uprooted due to the lack of time, plus one adult plant that was difficult to reach (located under a pile of branches). They will be uprooted in 2018, during the monitoring visit.

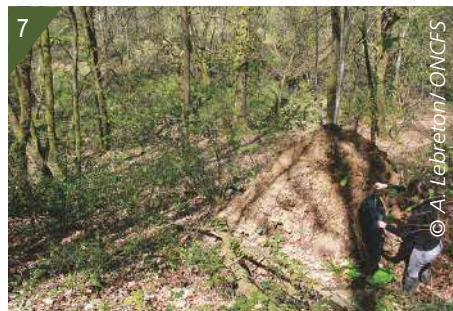
7. Deposit site for the yellow skunk cabbage.

- The resulting green waste was deposited near the work site to avoid any risk of dispersing the plants during the transport. It was placed in the hole left by an uprooted tree a few metres from the site and blocked with a bund. The hole was a very dry spot where the plants had no chance of regrowing and will rot. The rhizome of each plant was split in two to weaken it further and make sure it did not sprout.

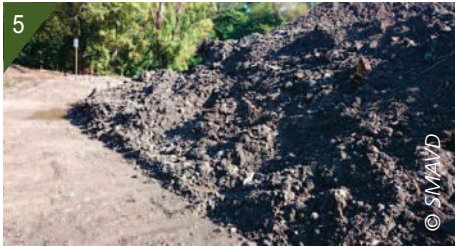
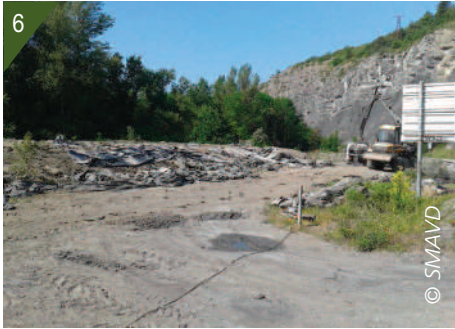
5. Rhizomes waiting to be ground up.  
6. Storage area.

- The soil was treated using the “grinding-tarping” technique. The soil was ground using a stone grinder to fragment the rhizomes and damage the fine roots:

- the machines were systematically cleaned before leaving the site.
- The soil was then covered for several months with opaque tarps that were not waterproof in order to block photosynthesis, but enable the rhizomes to rot:

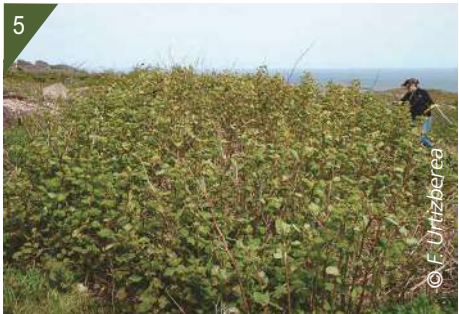
2. 3. 4. Typical Saint-Pierre-et-Miquelon landscapes.  
5. A stand of knotweed.

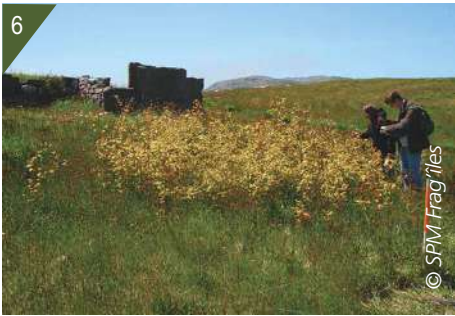
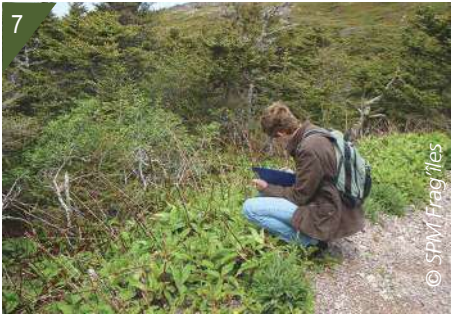
6. 7. Collecting data in the field.  
 8. Manual cutting of knotweed.

■ As the first step, all public land colonised by knotweed (Japanese and Himalayan) on the islands of Saint-Pierre, Miquelon-Langlade and Île aux Marins was precisely mapped. A team of four people equipped with a GPS, a tape measure and a pH meter travelled the islands during the summer period (23 June to 1 July 2010). The position and size of the knotweed stands was recorded, as was the soil pH data. A total of 497 knotweed stands, covering 25 231 square metres, were found (Table 1).

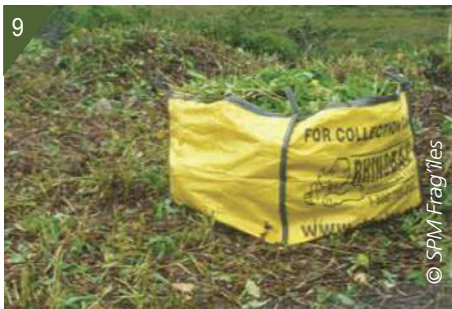
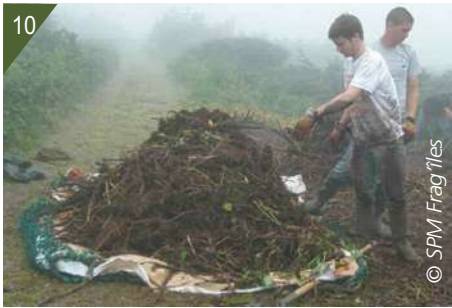
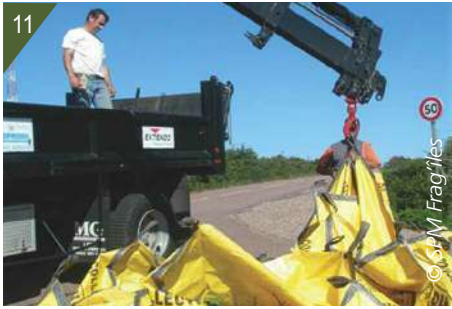
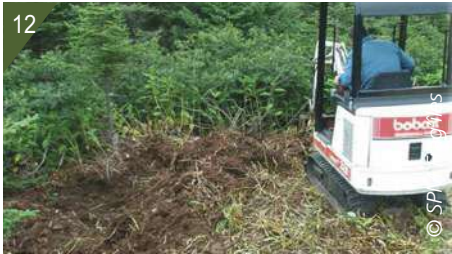
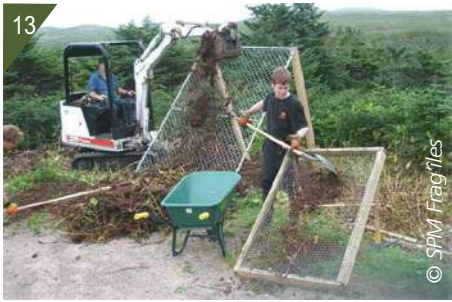
9. Storage in large bags for collection.  
 10. Uprooting, collection and storage of rhizomes.  
 11. Removal of the waste.  
 12. Scraping the surface with the small excavator.  
 13. Sieving the soil.

■ Special precautions were taken to avoid dispersal of the knotweed during the work, e.g. storage and burning of the waste, limited movements of machines and equipment, rigorous cleaning of machines and equipment before leaving the site.

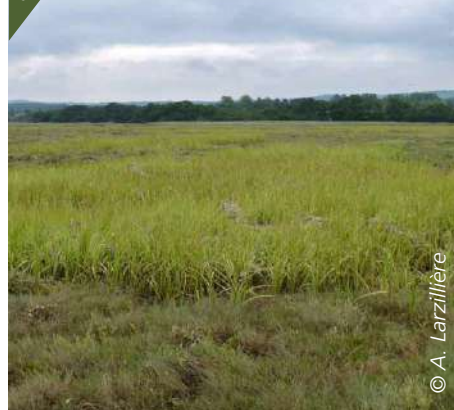
3

3. Area colonised by smooth cordgrass.

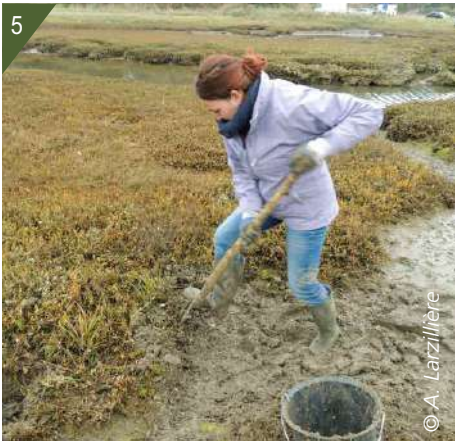
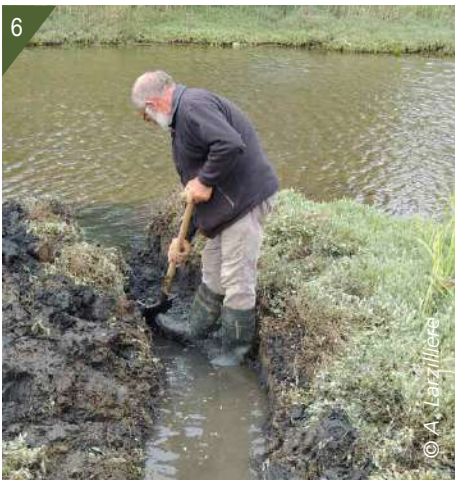
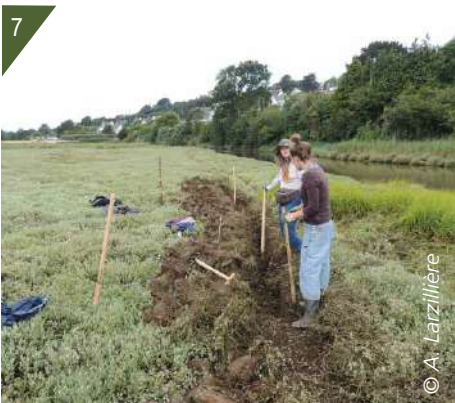
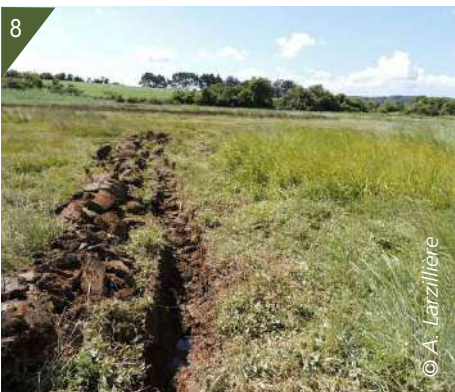
5. 6. 7. 8. Digging a ditch.

- No regrowth was observed in the scraped zones, on the condition that the rhizomes were completely removed.
- According to an experiment conducted by the National botanical conservatory between 2005 and 2010, tarps must remain in place for five years before the rhizomes are completely destroyed. Tests are now under way on shorter durations.
- *In situ* tests of rhizome germination are also being conducted.

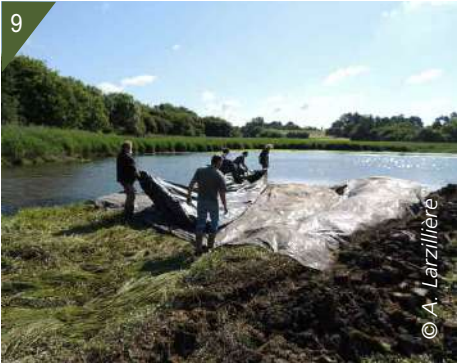
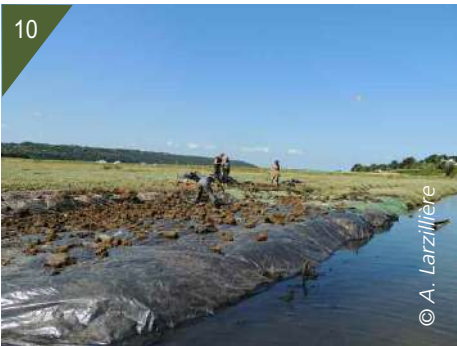
9. 10. Laying tarps.
