## Water primrose

### Managing water primrose in the Gardons basin Management report on four years of work

#### Board for balanced management of the Gardons basin (SMAGE des Gardons)

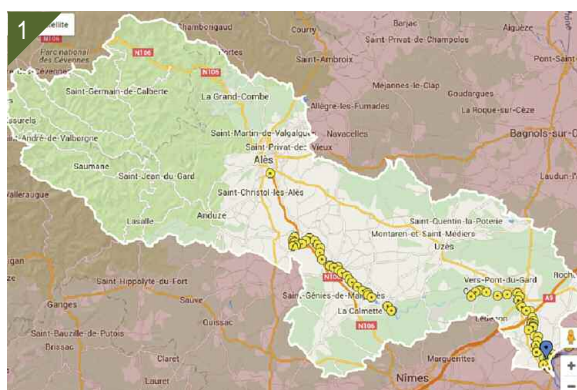
1. Presence of water primrose in the Gardons basin in 2015.  
2. Sites where work on water primrose was done in 2012.

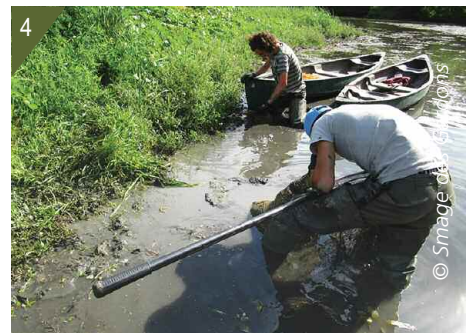
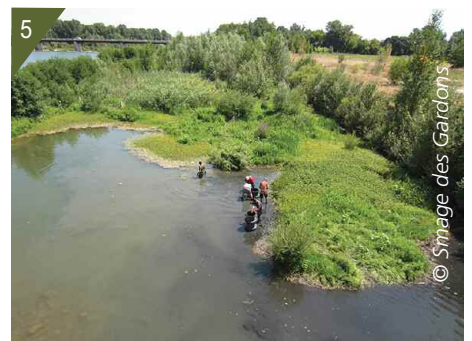
4. 5. Manual uprooting.

- The river reaches to be treated were very long and could not be handled by a single firm, which explains why the work was divided into sectors.
- Depending on the quantities of water primrose and the period of the year, the work teams (one per sector) consisted of four to ten people on foot, assisted by one or two motorboats, and equipped with nets and sacks.

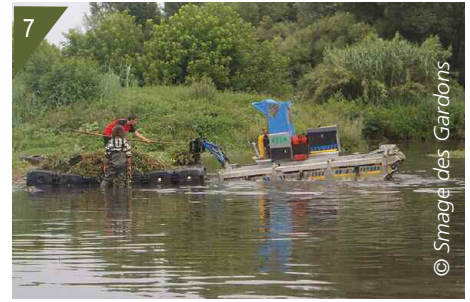
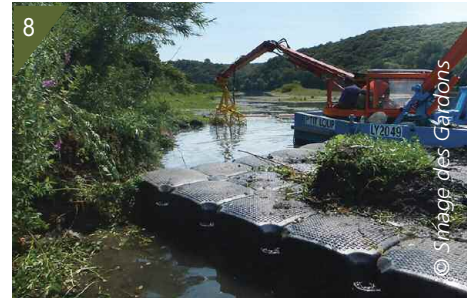
7. 8. Mechanical uprooting with the harvester boat and the raft used to remove the harvested plants (Figure 7), and the boat with the crane and the raft (Figure 8).

■ The first phase of mechanical uprooting was carried out in 2012. The equipment included a harvester boat, an amphibious excavator and a crane mounted on a boat with very little draft. The harvested plants were transported on a barge to the opposite bank.

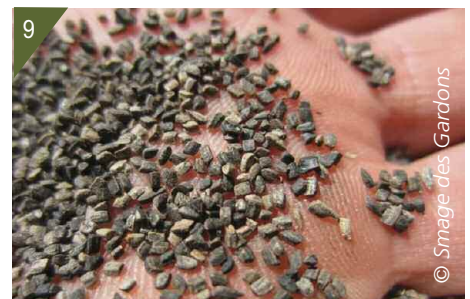
9. Seeds freed from the sediment.  
10. Nets were installed to avoid dispersal of fragments of water primrose during mechanical uprooting.

■ During this first phase, significant amounts of seeds freed from the sediment began to germinate. The seeds settled and germinated on the treated sites and on further sites hundreds of metres downstream, at the foot of the river banks and in the accumulated debris. This reduced the effectiveness of the work and study was put into developing other harvesting techniques.

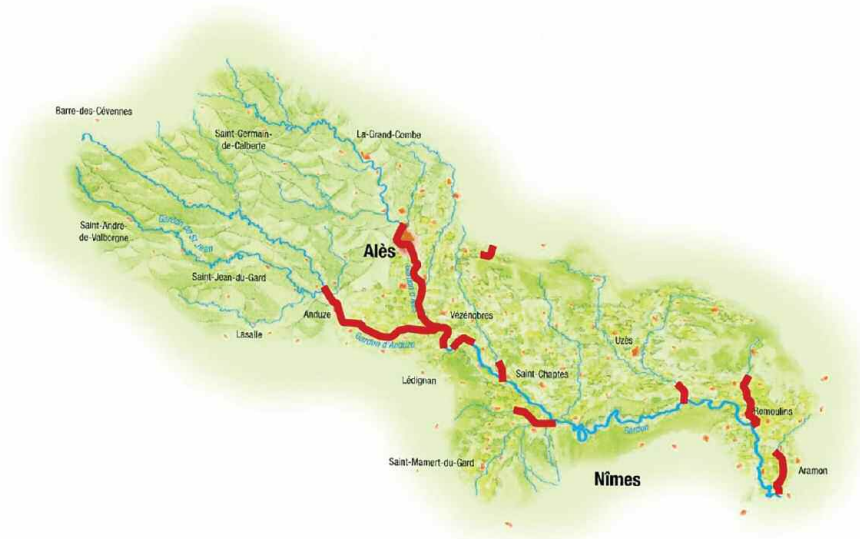
Map showing the river sections monitored annually.

- Each year since 2013, 60 kilometres of river have been inspected.
- This work limits the risks of seeing the areas colonised by water primrose grow, while also ensuring the early detection of the other targeted species.
