Water fern

(*Azolla filiculoides*)

Manual uprooting to eradicate water fern from the Coste pond (Côtes d'Armor department)

Saint-Brieuc Armor Urban Area (SBAA)

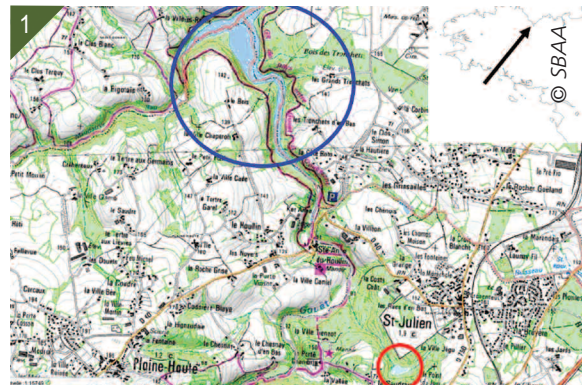
1. The Coste pond (red circle) and the reservoir behind the Saint-Barthélemy dam (blue circle).
2. The pond entirely covered by water fern.

- The Coste pond is located in the town of Saint-Julien, just to the south of Saint-Brieuc. It covers a total surface area of 8 000 square metres, has a maximum depth of four metres and is situated 500 metres downstream of the source that supplies it with water. Downstream of the pond, a stream flows into the Gouët, a small river that flows 1.2 km further downstream into an 80 hectare reservoir used for drinking water.

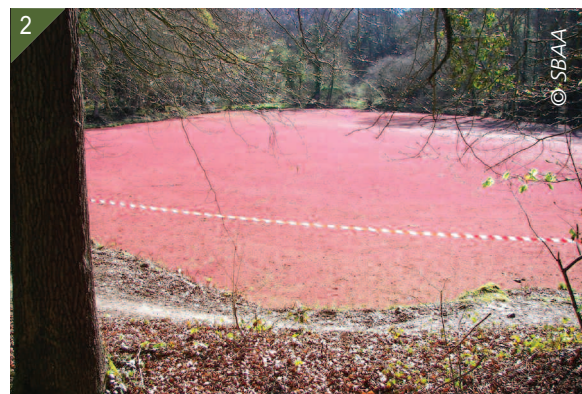
- The water fern had grown very densely and covered the entire pond, with in addition a significant layer of dead stems under the water surface.

- A thick blanket of fern covering the entire pond reduces the light in the water and results in anoxic conditions that are lethal to many species of fish (pike, roach, perch, rainbow trout), molluscs and plants.

- Access to the pond was blocked off to prevent any risk of drowning given that the water was not visible under the layer of plants.
- The fishing competitions and all fishing activities were halted by the hunting society.

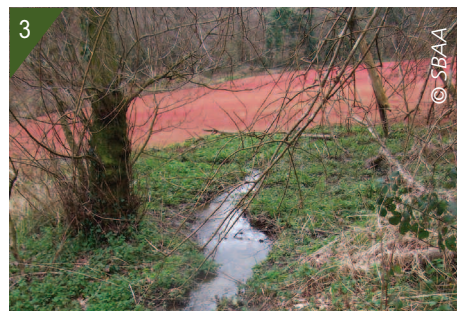
3. Stream feeding into the pond.

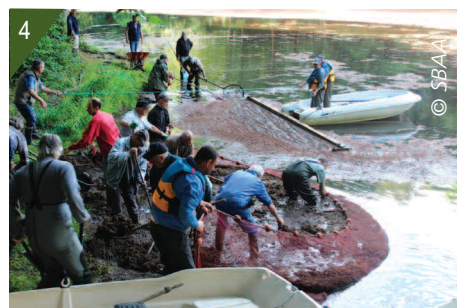
4. Net full of water fern, pulled up on the bank.

■ Using dip nets and nets with a one-centimetre mesh, the beds of water fern were gathered and pulled to the banks. Boats were used to access the centre of the pond.

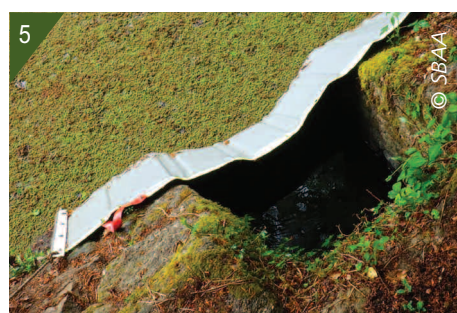
5. Barrier used to avoid the dispersal of water fern.

■ Prior to the work and to avoid any risk of dispersal downstream, a siphon was installed at the outlet of the pond, with a floating barrier of the type used to contain hydrocarbon pollutants in water.

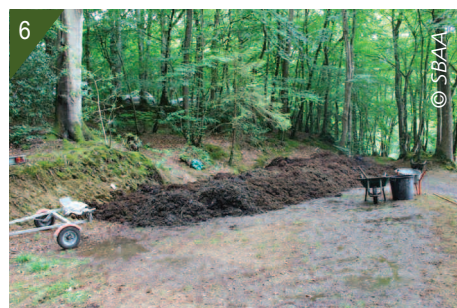
6. Swath of water fern for draining and drying prior to transport.

■ The collected water fern was laid out in swaths near the pond to drain and then transported to a disposal centre at the end of the summer and folded into a compost-production line (in the “green algae” circuit where it is first dried before being mixed with standard green waste).

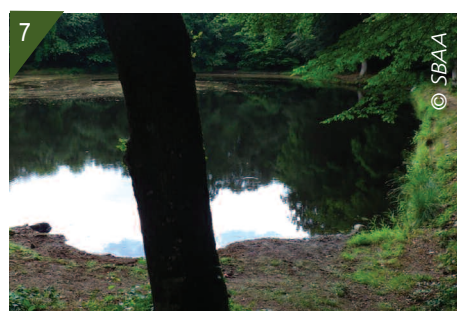
7. The pond the day after the work.

■ In July 2016, the work covered the entire pond and approximately 50 cubic metres of water fern were removed from the water, drained, dried and transported. With the exception of the small, isolated section to the north of the pond discovered in August 2016, no further discoveries of water fern were reported during the inspections.

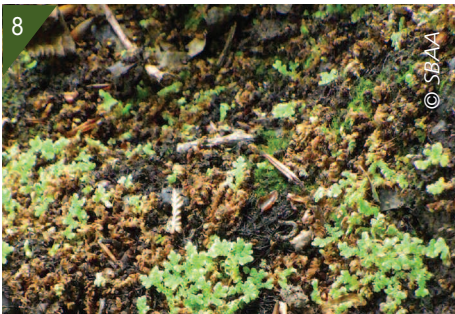
■ In the beginning of August 2016, approximately one month after the work, the technician in charge of inspecting the site found some water fern growing on about 2.2 square metres of wetland (saturated soil comprising mud and sand) to the north of the pond, just a few metres from the water. With the help of the president of the hunting society and using a shovel, the technician carefully scrapped up the plants, starting from the outside and working in to avoid missing or dispersing any fragments. This additional work took approximately one hour. The removed water fern was transported in a plastic garbage bag and added to the swath of water fern collected in July.

- 8. The small group of water-fern plants found to the north of the pond in August 2016.
- 9. The pond four months after the work.
- 10. An article published in the Télégramme newspaper on 24 March 2016.

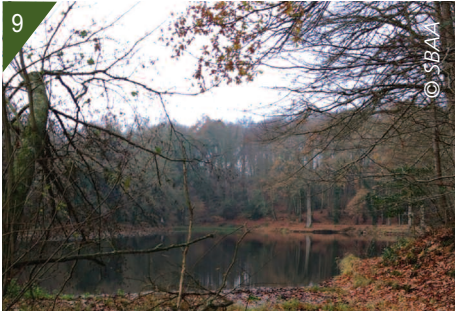
■ Two and a half years after the work, no water fern has been observed on the site.
